## **LEUCADIA WASTEWATER DISTRICT SEWER SYSTEM MANAGEMENT PLAN FISCAL YEAR 2021 AUDIT**

**October 22, 2021**

**Prepared by:  
Dexter Wilson Engineering, Inc.  
2234 Faraday Avenue  
Carlsbad, CA 92008**

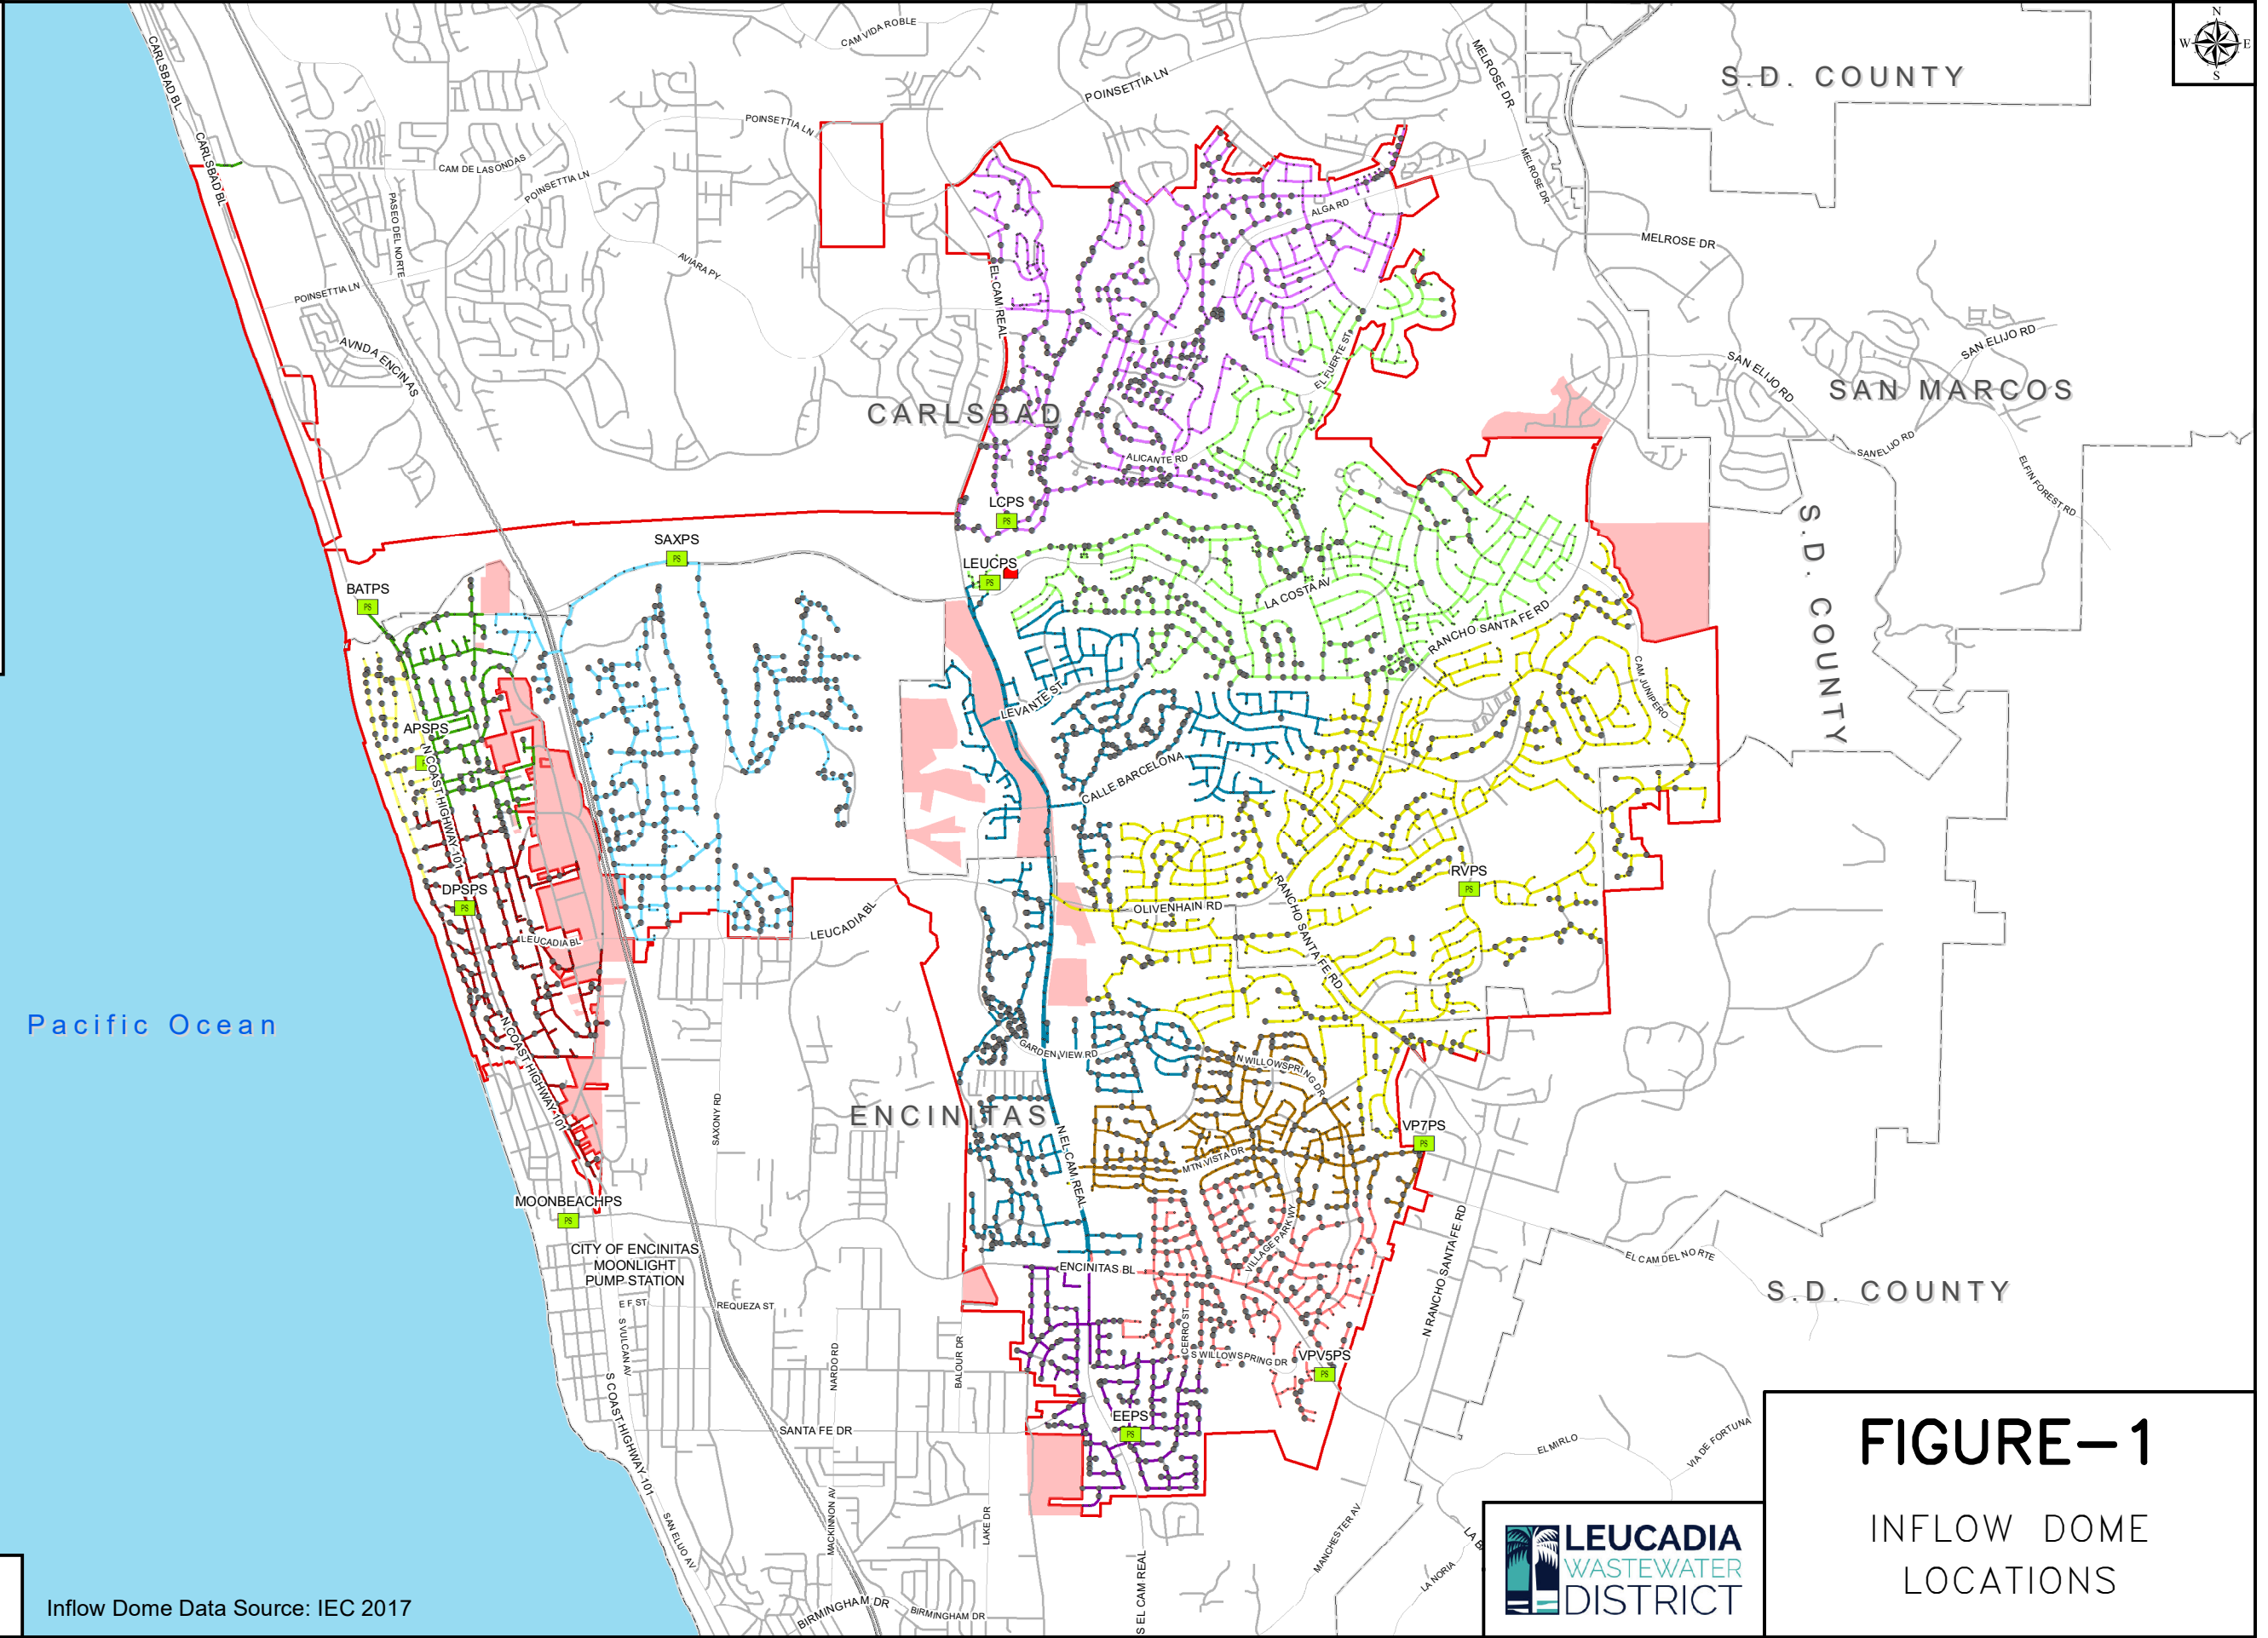
**FIGURE—1**

Inflow domes have been installed in 2,414 of the District's 5,103 manholes to aid in reducing inflow. The District will continue to repair/replace inflow domes as it becomes necessary. Figure 1 shows the manhole locations where inflow domes have been installed throughout the District.

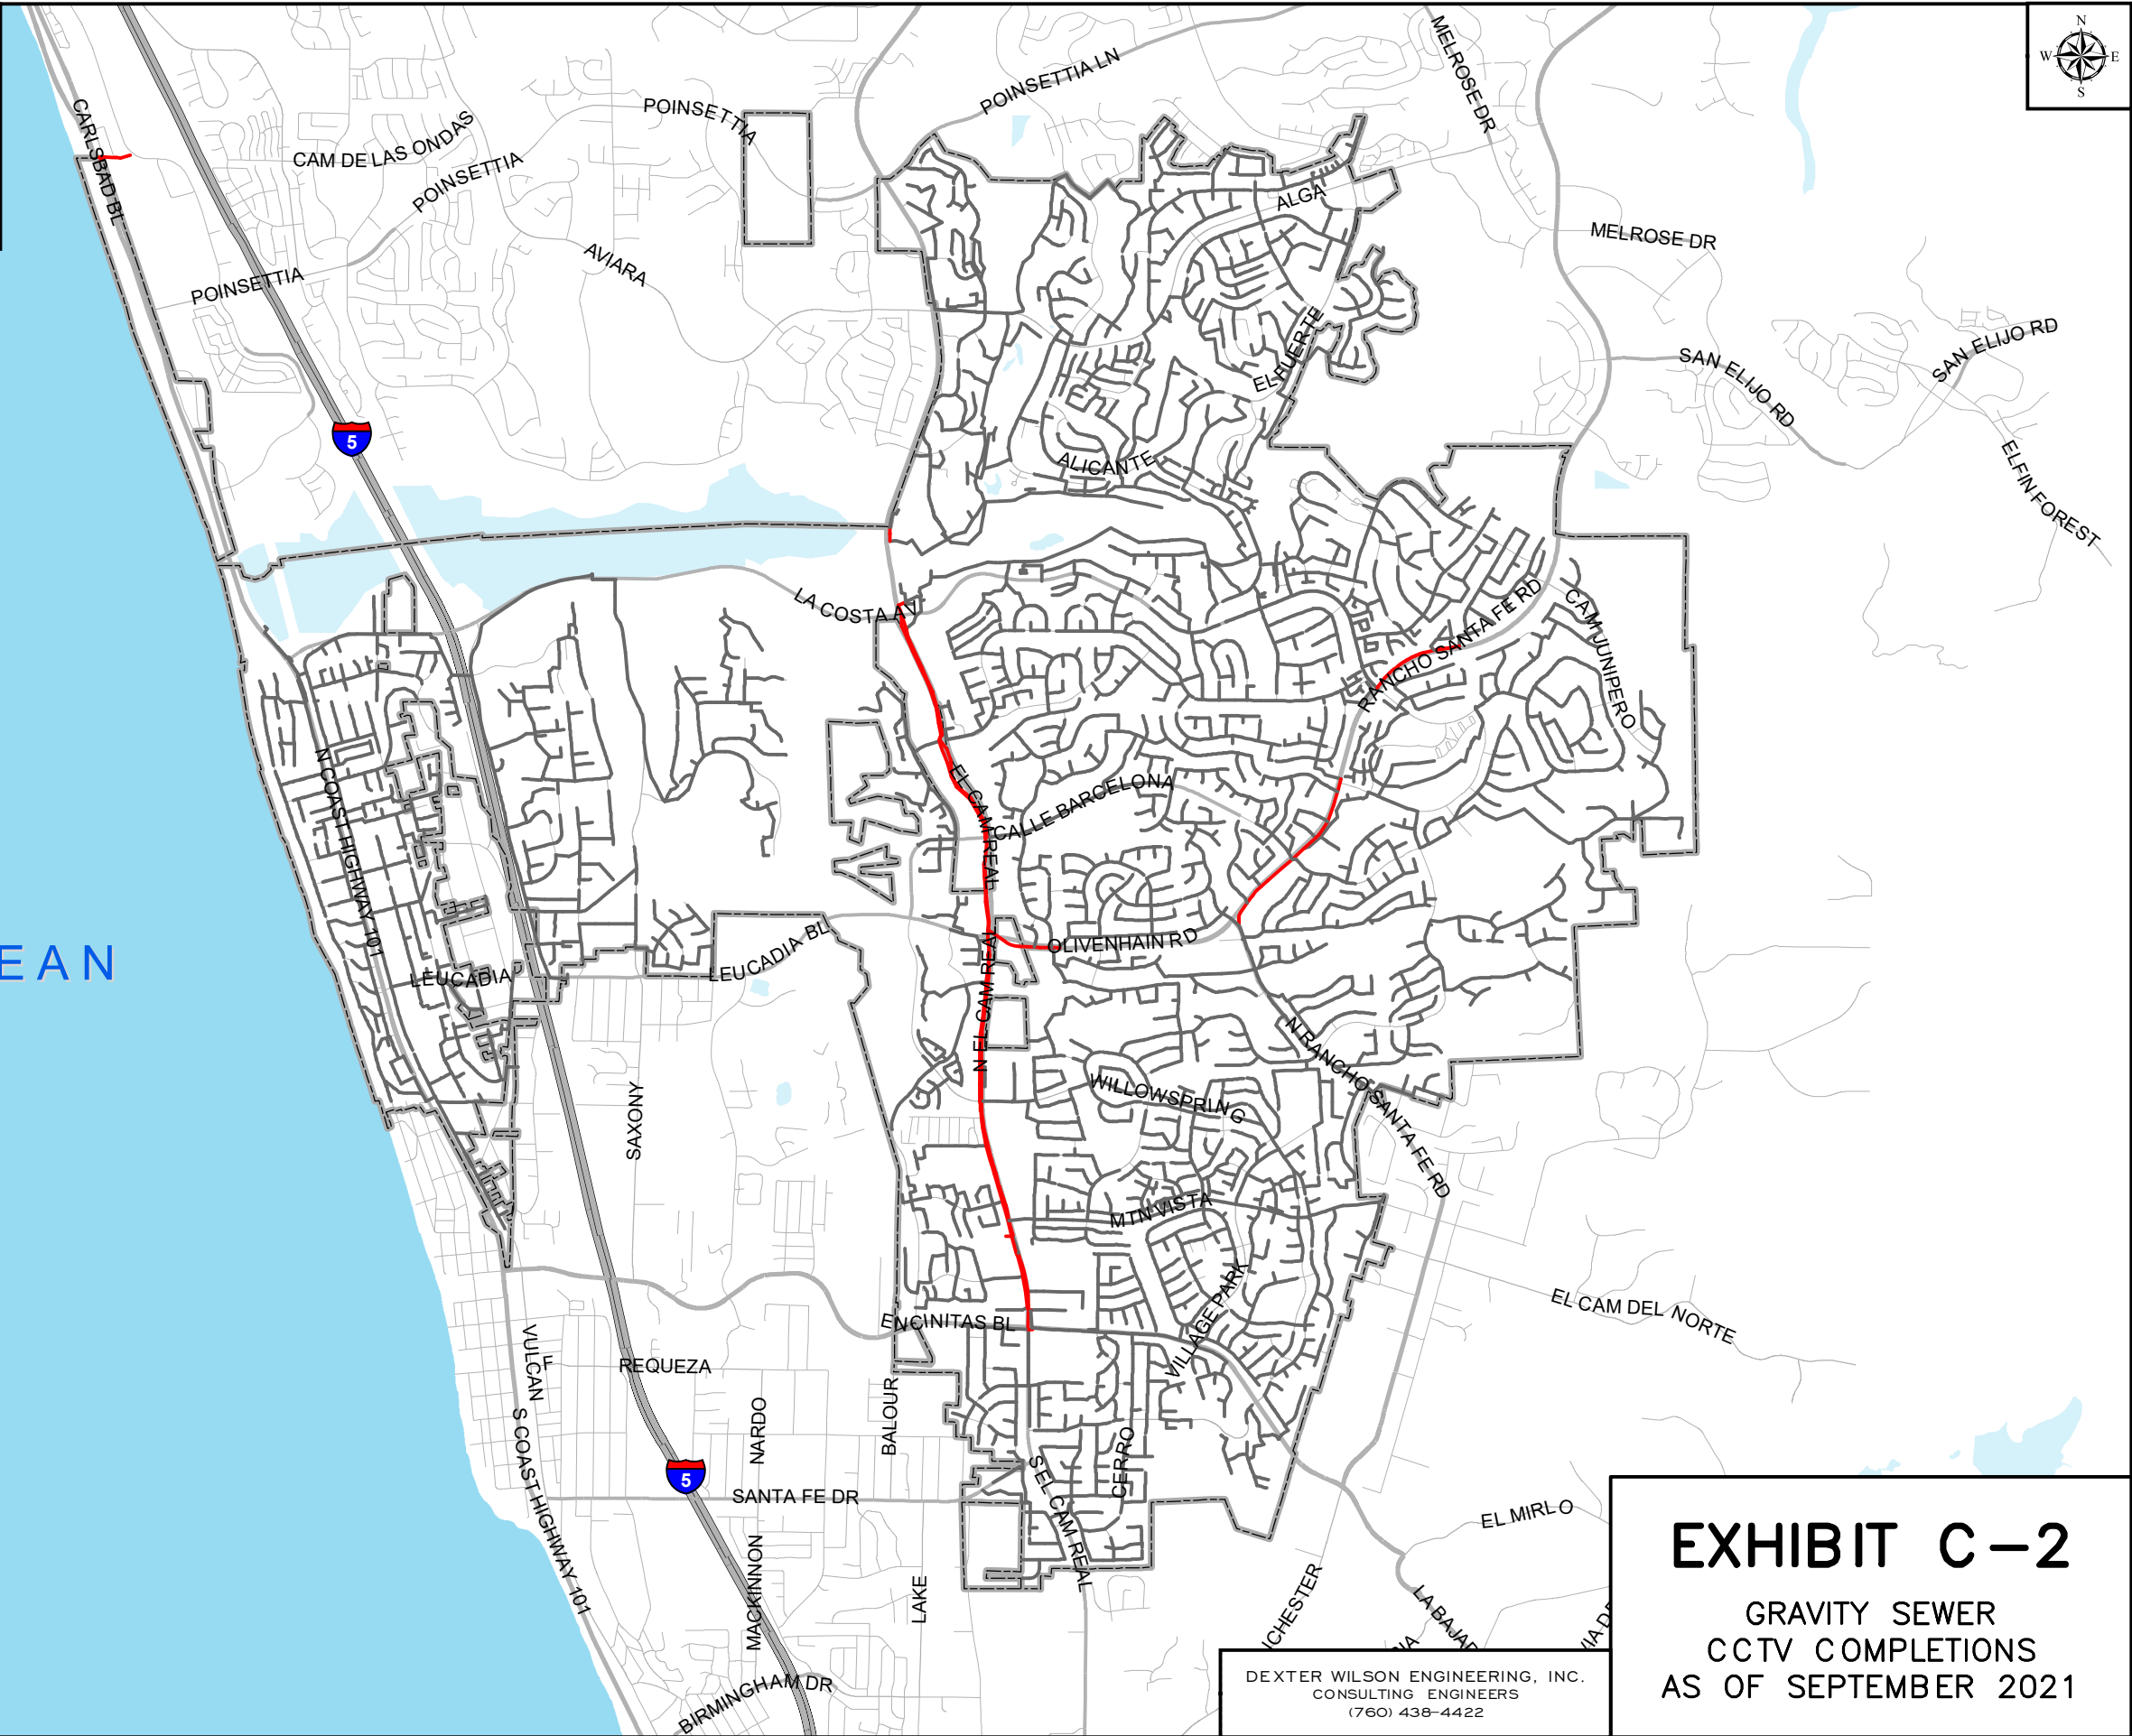
**EXHIBIT C-2**  
GRAVITY SEWER  
CCTV COMPLETIONS  
AS OF SEPTEMBER 2021

Exhibit C-2 tracks the general progress of CCTV inspections in the District. Per the District's SSMP, the District strives to CCTV their entire system every three years. The District is on track to meet its goal of CCTV inspecting its 200 mile gravity sewer system within a three-year timeframe. However, in review of Exhibit C-2, there are select areas within the District which have not been CCTV inspected in the last three years. These areas will be CCTV inspected in FY22.

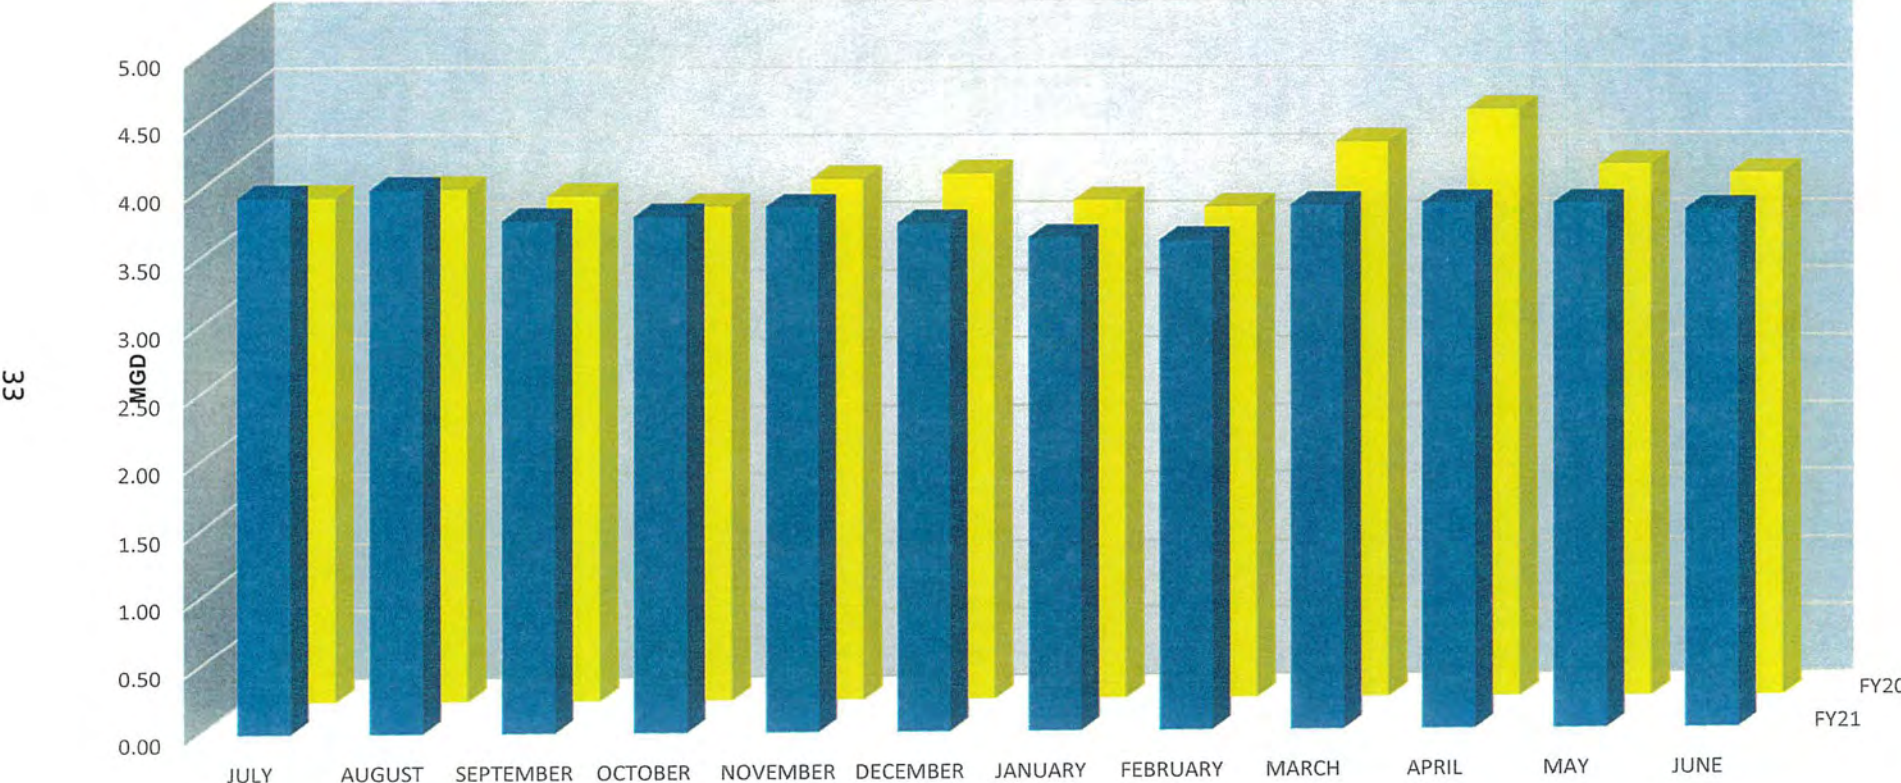
**DISTRICT FLOW COMPARISON FY20 TO FY21**

The District's monthly flow comparison for FY20 and FY21 can be found in Attachment F. In comparison to FY20, average daily flows have slightly decreased in FY21.

**FY20 Avg. Daily Flow = 3.96 MGD**  
**FY21 Avg. Daily Flow = 3.88 MGD**
