## **LEUCADIA WASTEWATER DISTRICT SEWER SYSTEM MANAGEMENT PLAN FISCAL YEAR 2022 AUDIT**

October 31, 2022

**Prepared by:  
Dexter Wilson Engineering, Inc.  
2234 Faraday Avenue  
Carlsbad, CA 92008**

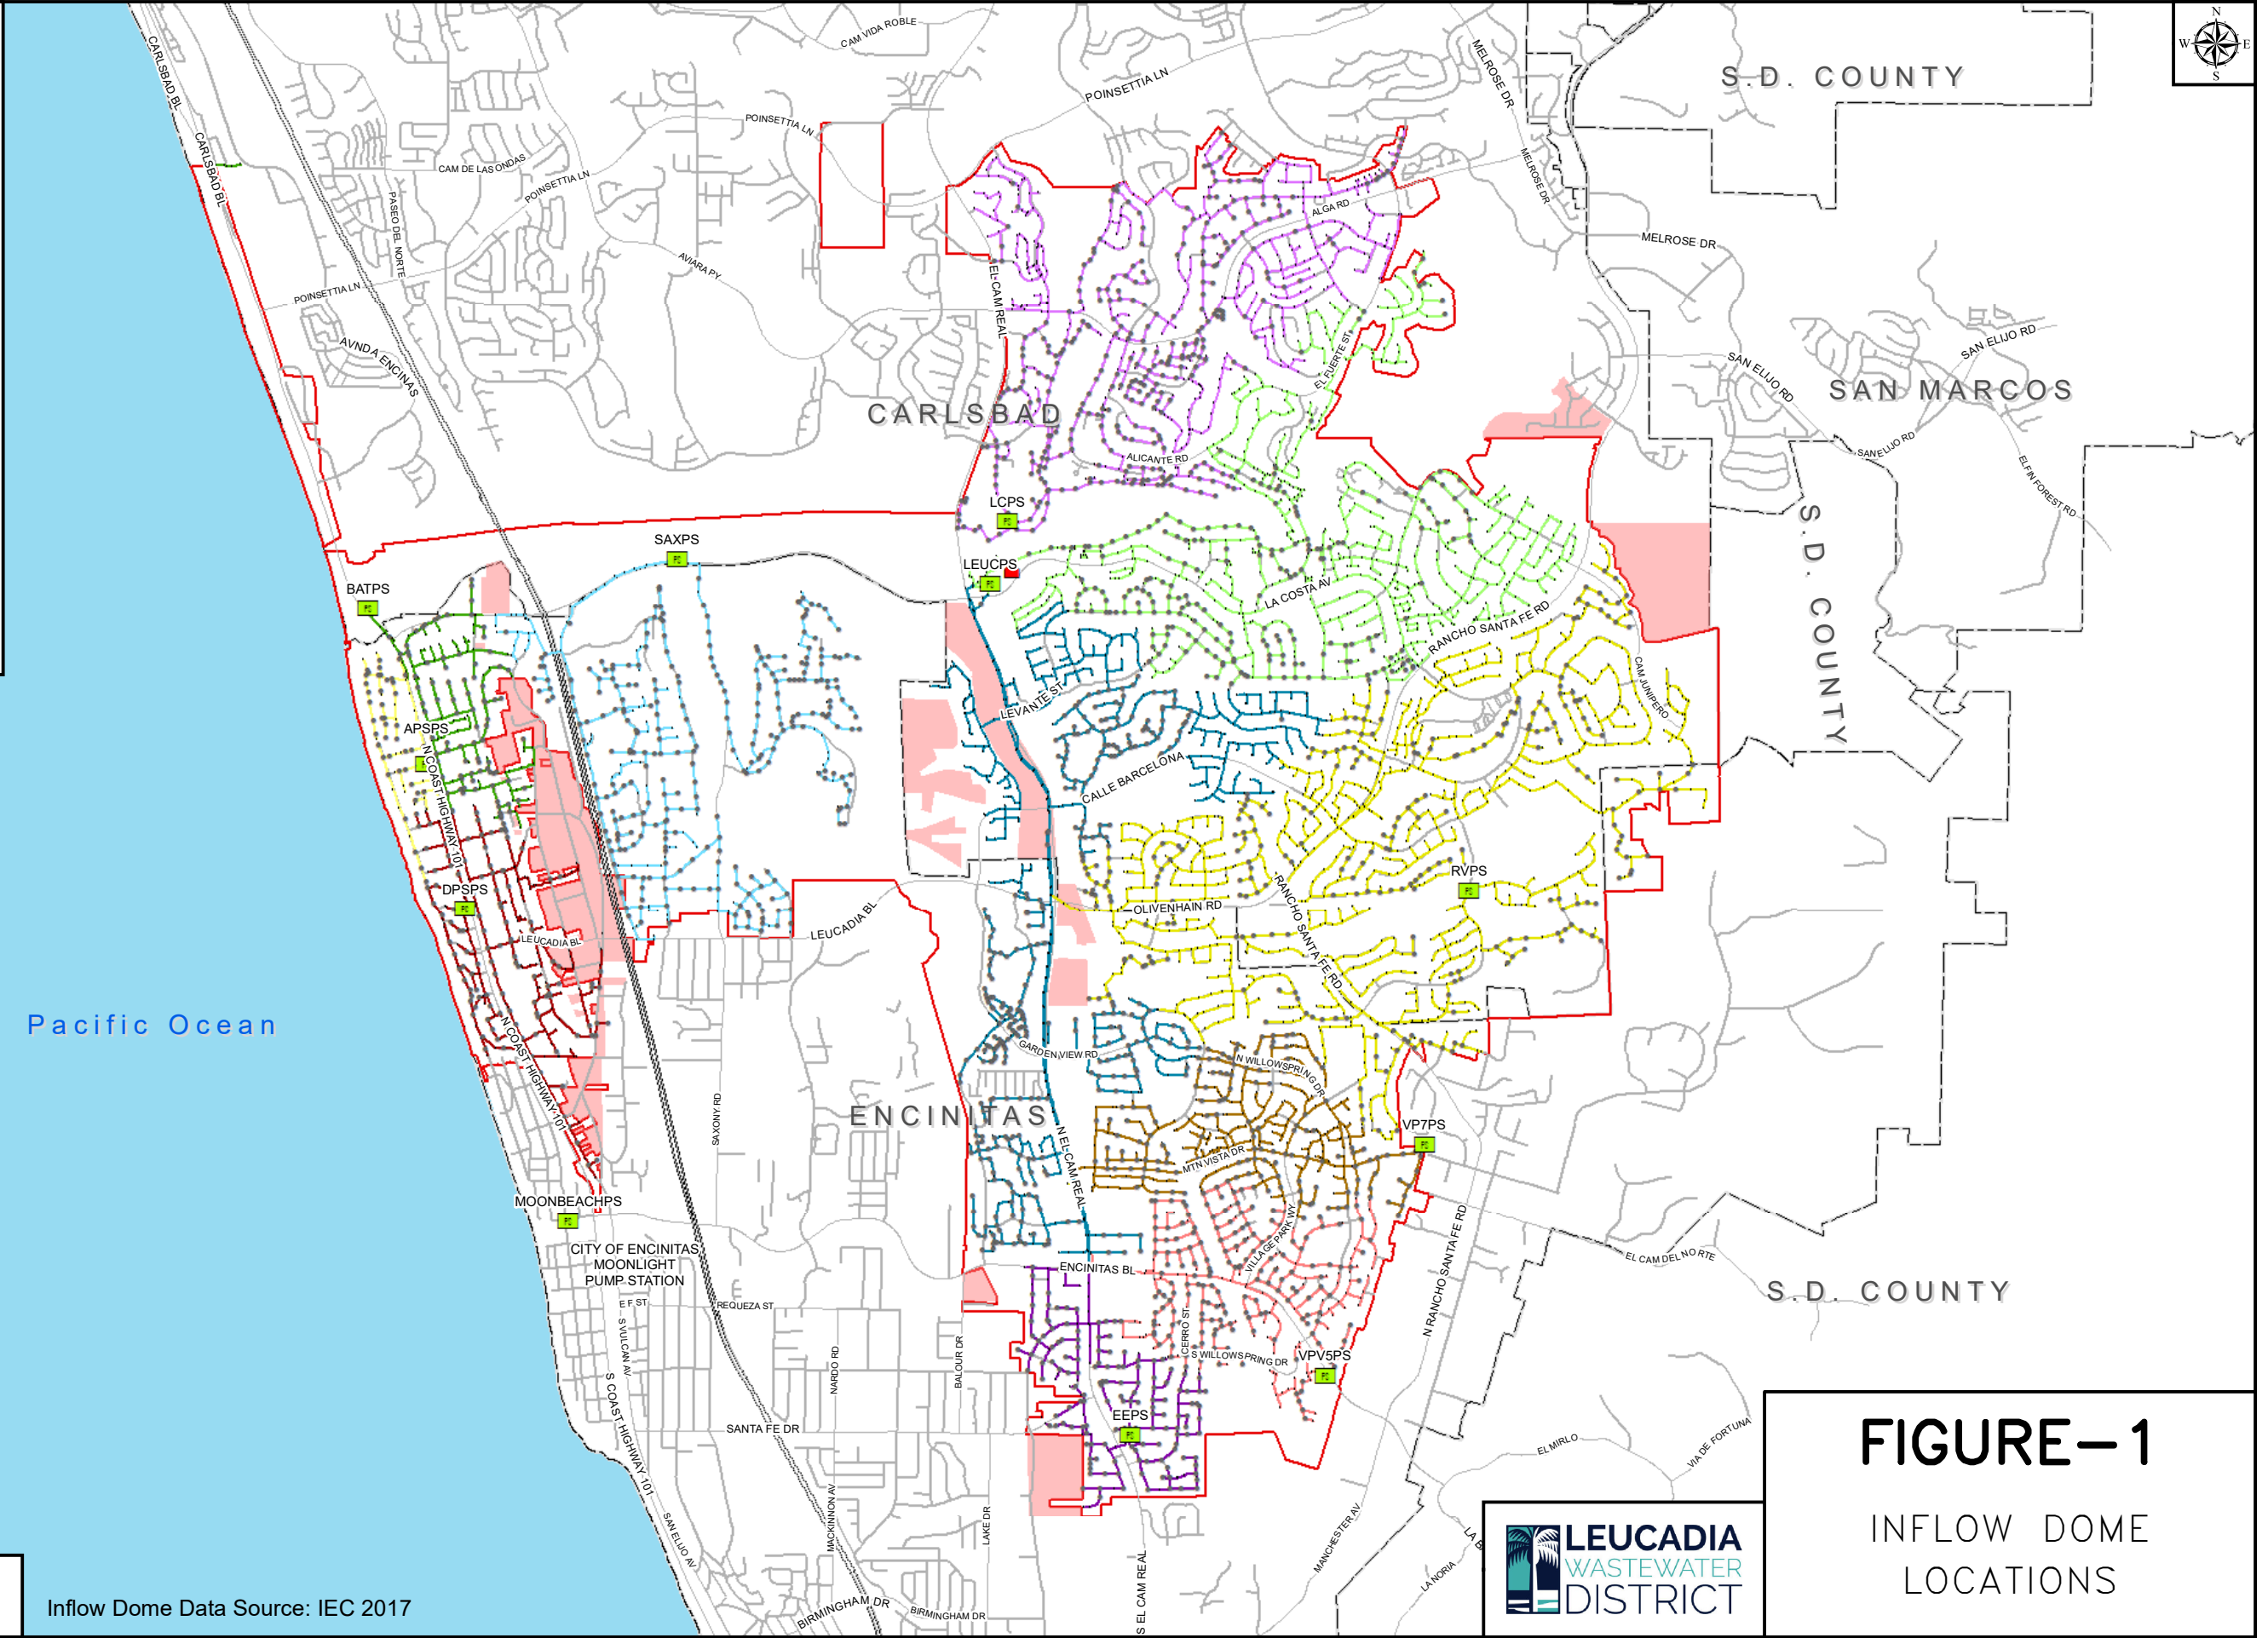
Inflow domes have been installed in 2,455 of the District's 5,103 manholes to aid in reducing inflow. The District will continue to repair/replace inflow domes as it becomes necessary. Figure 1 shows the manhole locations where inflow domes have been installed throughout the District.

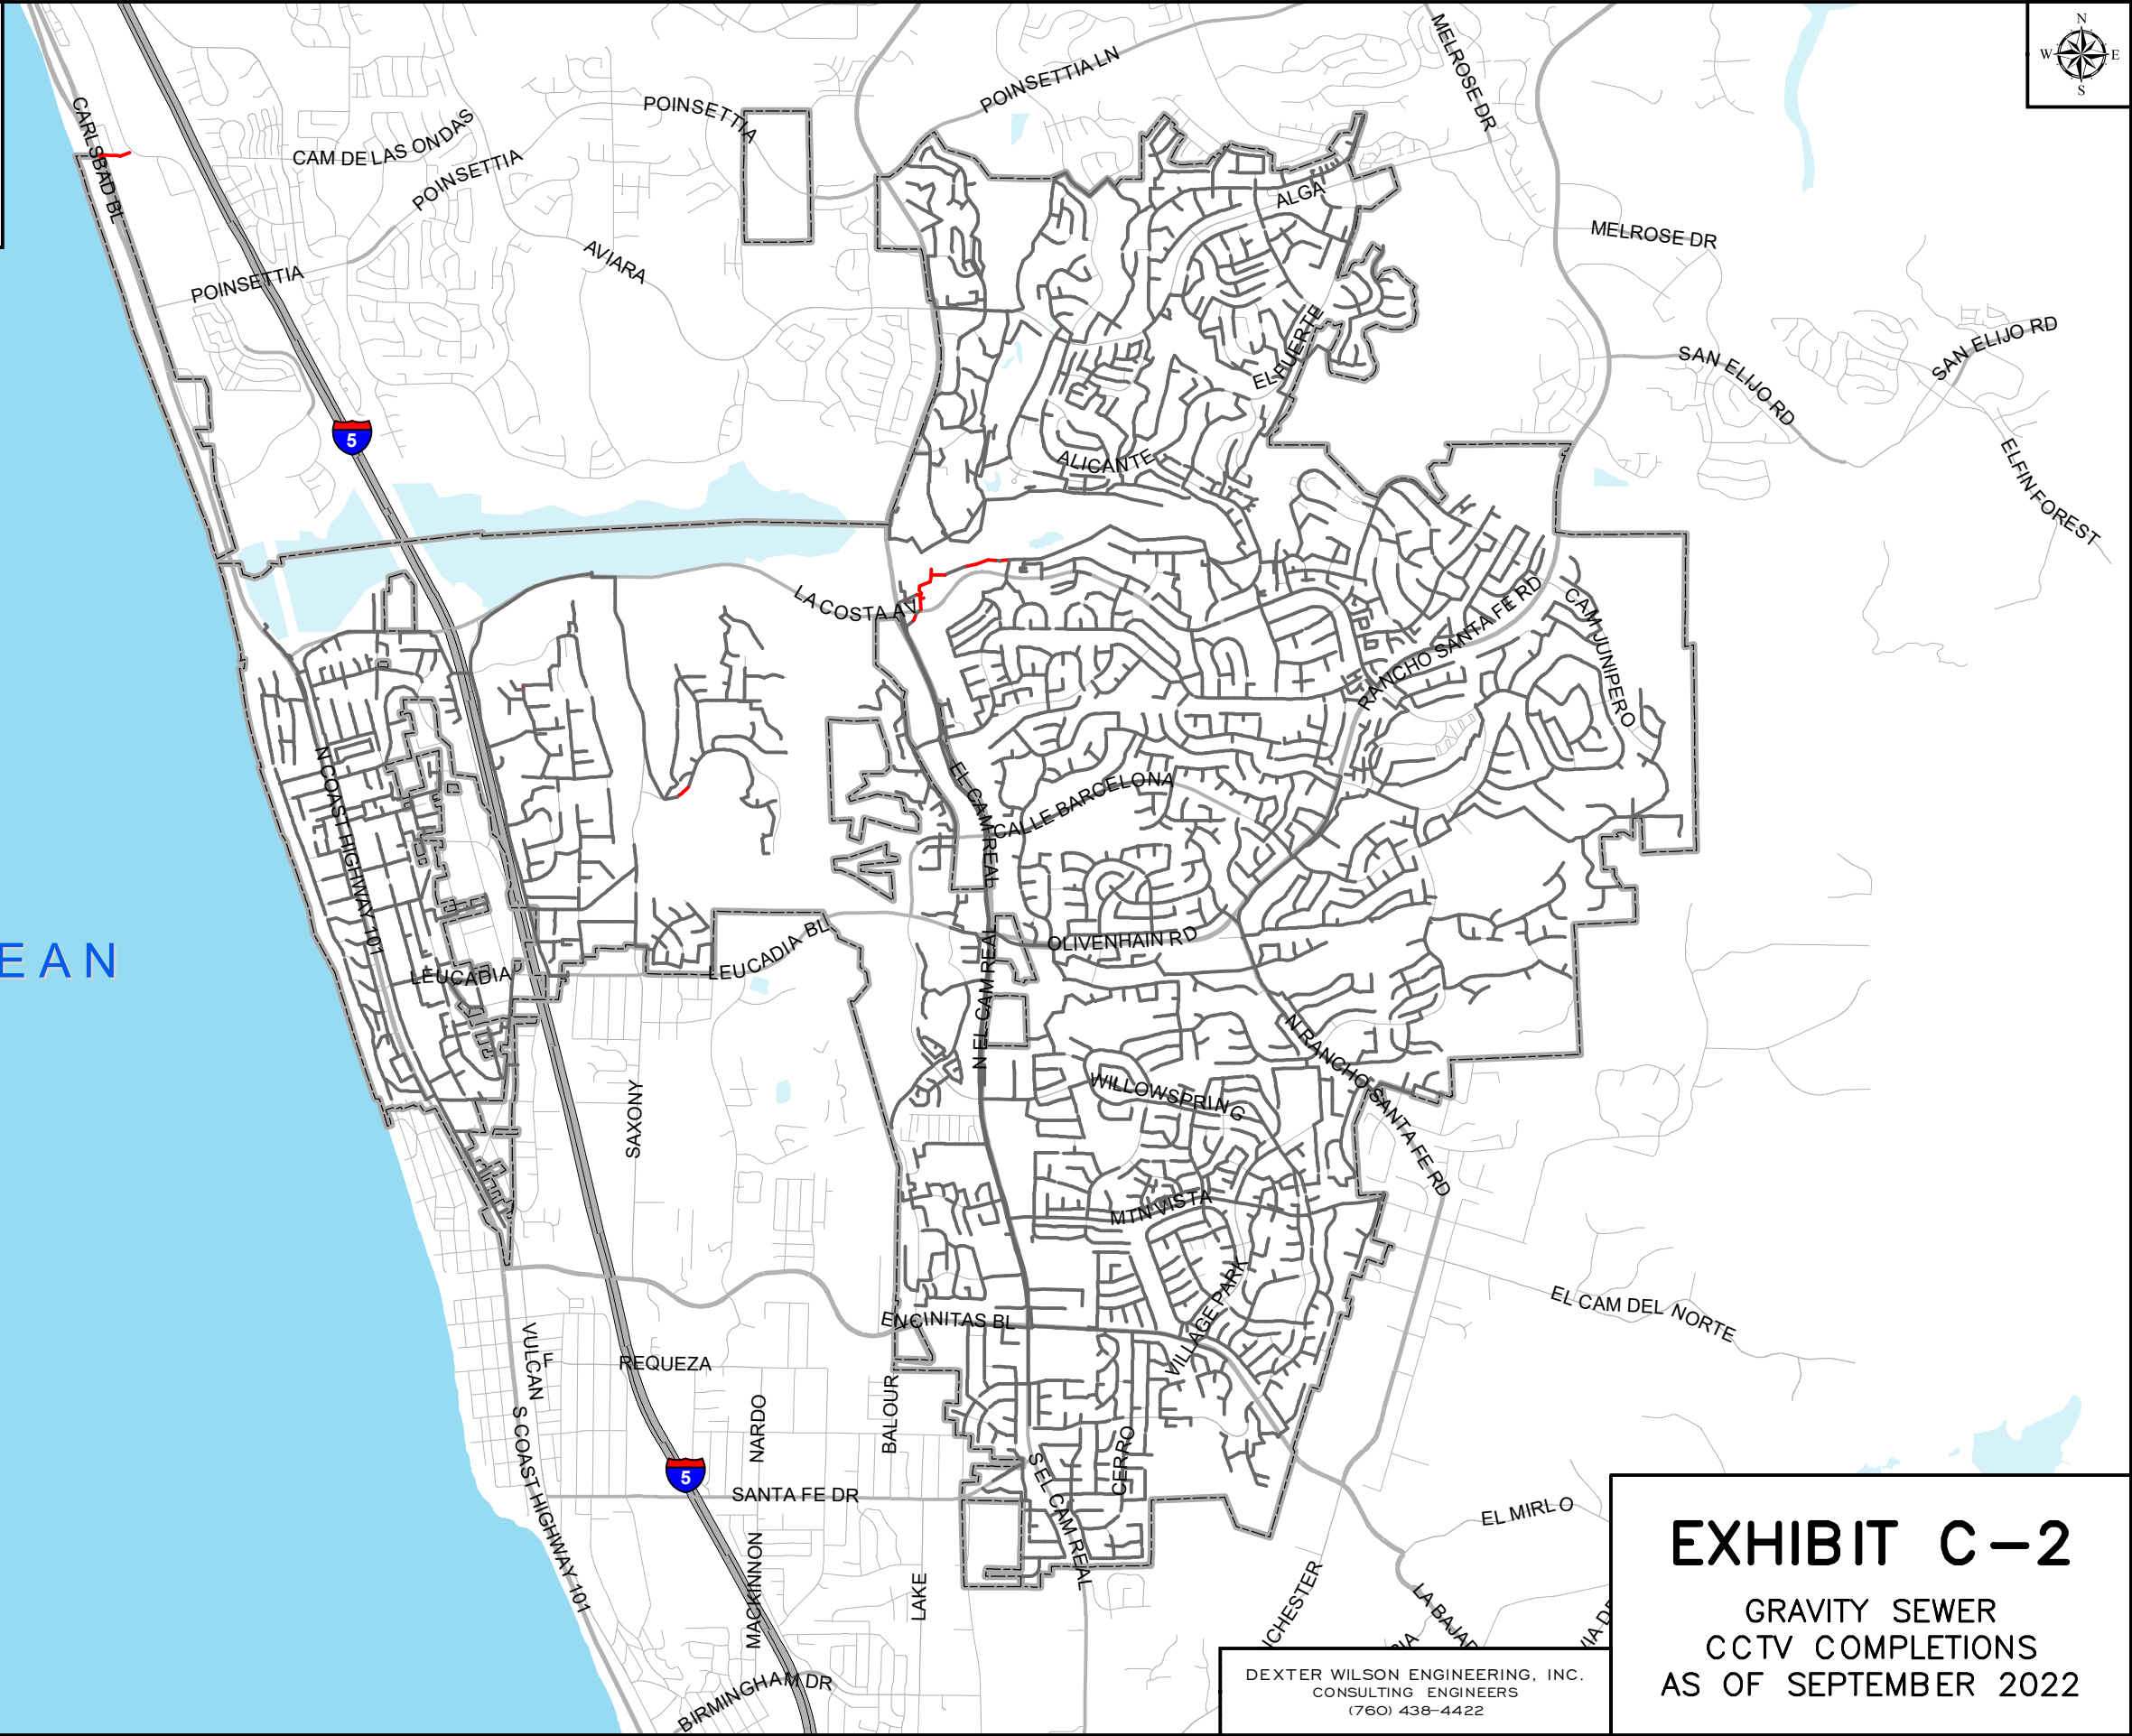
**EXHIBIT C-2**  
GRAVITY SEWER  
CCTV COMPLETIONS  
AS OF SEPTEMBER 2022

Exhibit C-2 tracks the general progress of CCTV inspections in the District. Per the District's SSMP, the District strives to CCTV their entire system every three years. The District is on track to meet its goal of CCTV inspecting its 200 mile gravity sewer system within a three-year timeframe. However, in review of Exhibit C-2, there are select areas within the District

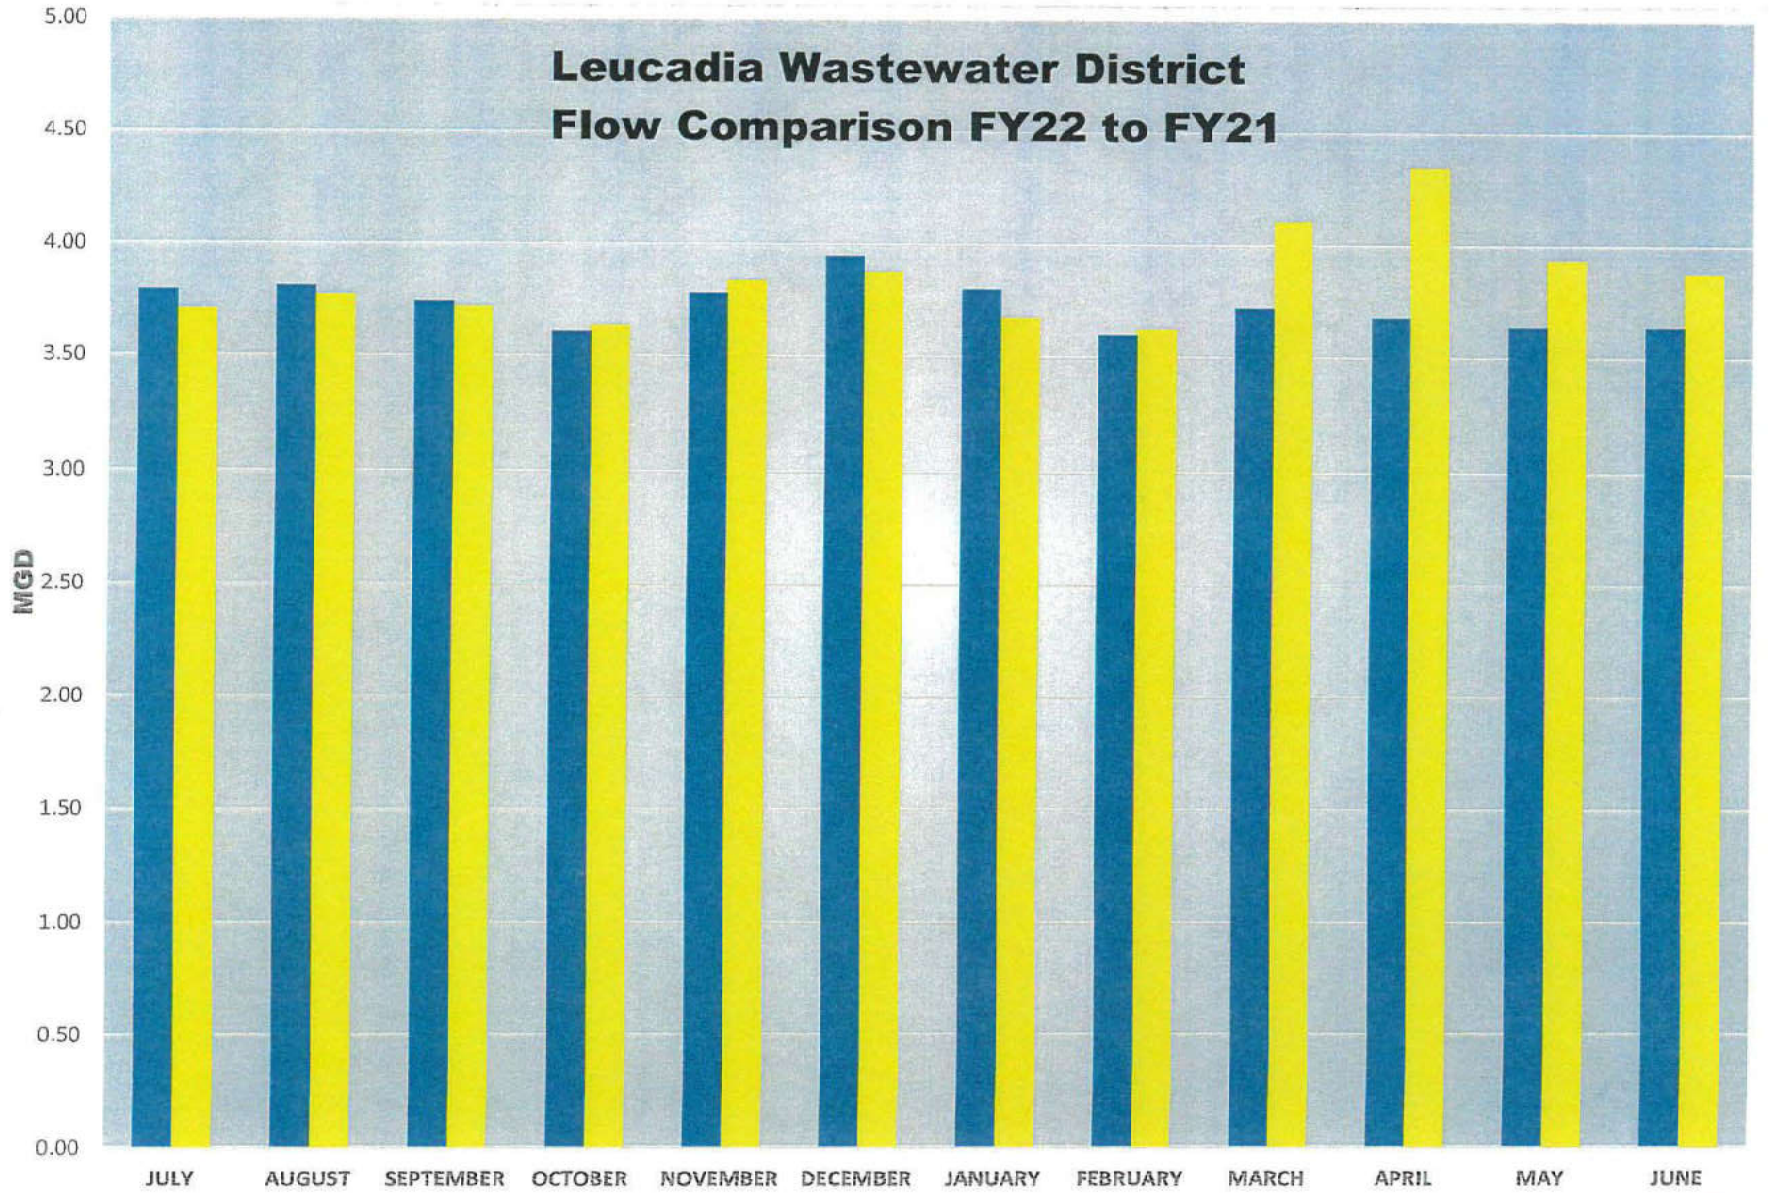
### Leucadia Wastewater District Flow Comparison FY22 to FY21

The District's monthly flow comparison for FY21 and FY22 can be found in Attachment F. In comparison to FY21, average daily flows have slightly decreased in FY22.

**FY21 Avg. Daily Flow = 3.88 MGD**  
**FY22 Avg. Daily Flow = 3.75 MGD**
