LEUCADIA WASTEWATER DISTRICT SEWER SYSTEM MANAGEMENT PLAN FISCAL YEAR 2020 AUDIT

November 4, 2020

Subject: Leucadia Wastewater District Sewer System Management Plan Fiscal Year 2020 Audit

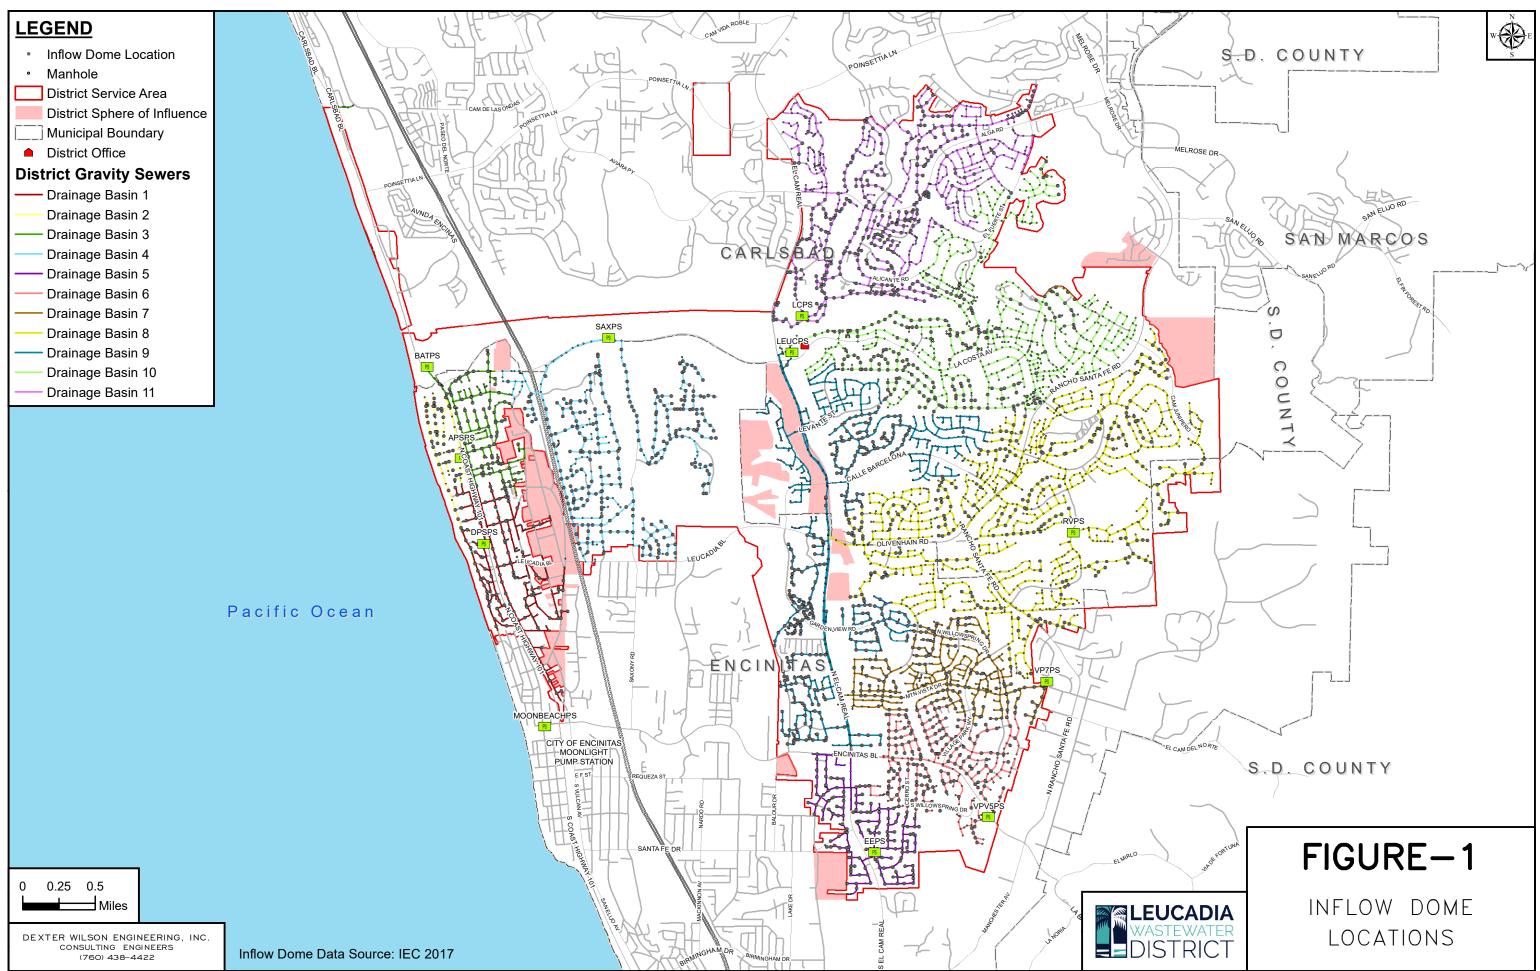
Inflow domes are present in 2,414 of the District's 5,103 manholes to aid in reducing inflow. Figure 1 shows the manhole locations where inflow domes have been installed throughout the District.
