## **LEUCADIA WASTEWATER DISTRICT SEWER SYSTEM MANAGEMENT PLAN FISCAL YEAR 2021 AUDIT**

**October 22, 2021**

**Prepared by:  
Dexter Wilson Engineering, Inc.  
2234 Faraday Avenue  
Carlsbad, CA 92008**

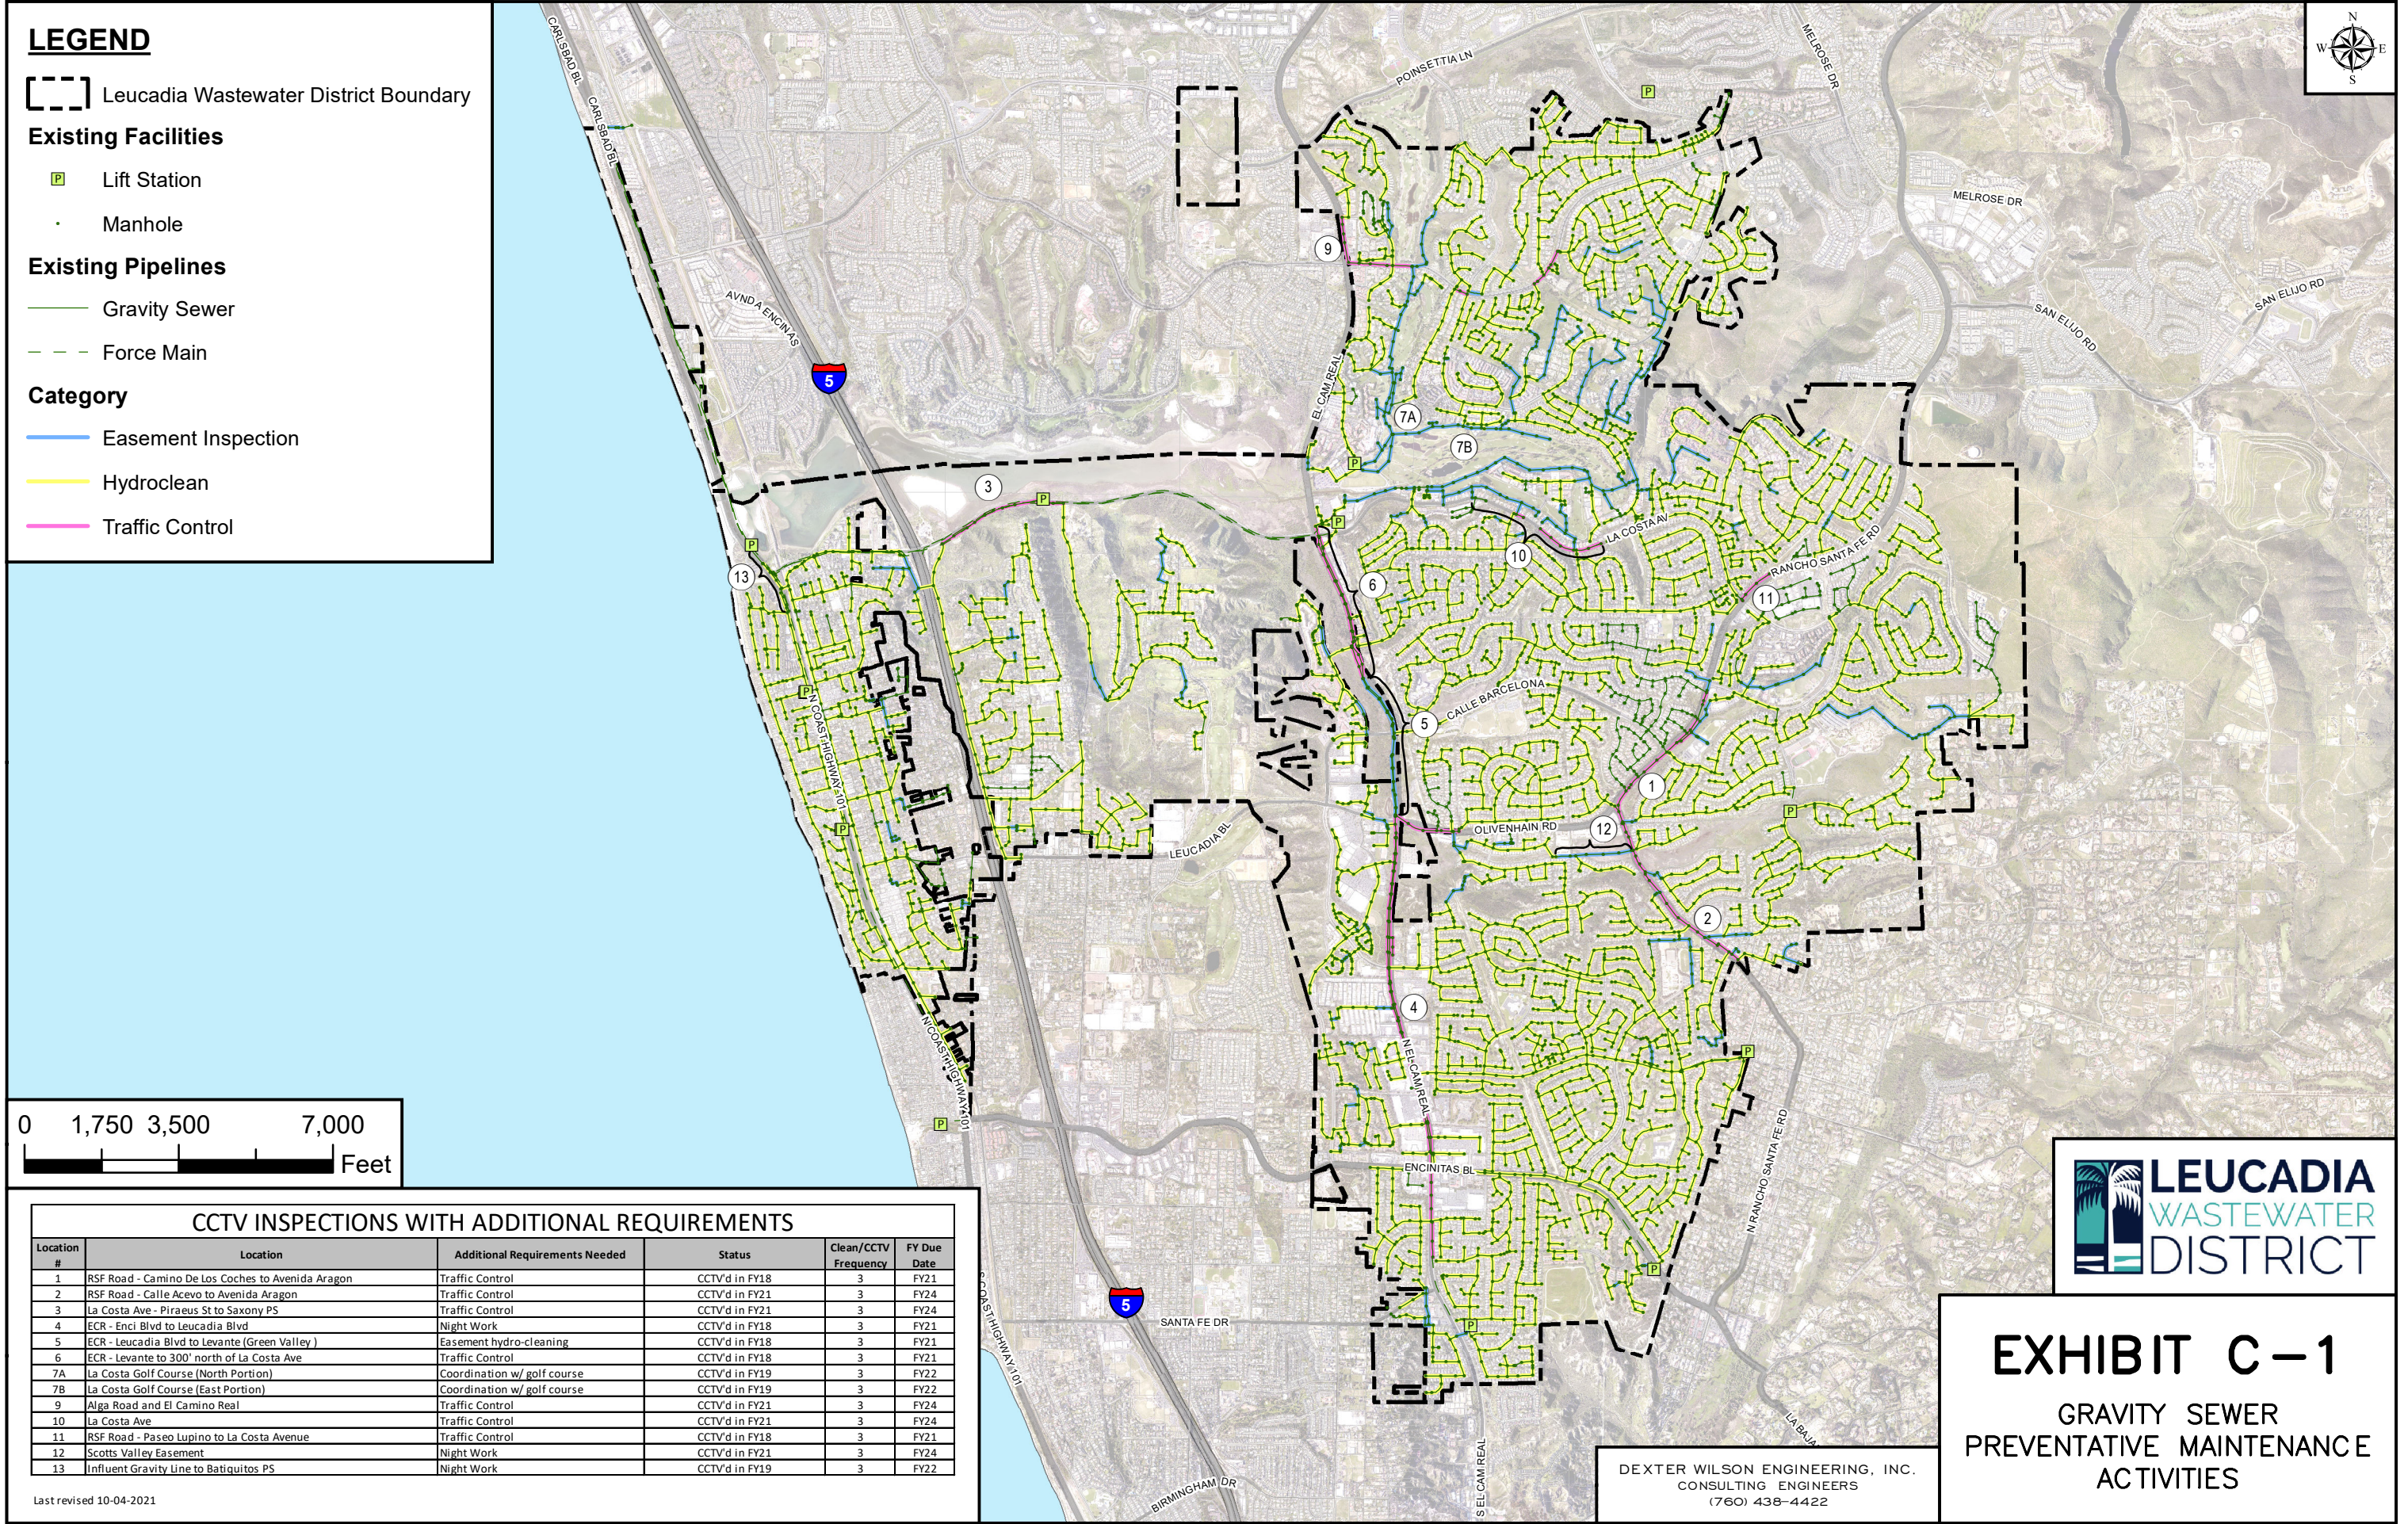
### CCTV INSPECTIONS WITH ADDITIONAL REQUIREMENTS

Location #	Location	Additional Requirements Needed	Status	Clean/CCTV Frequency	FY Due Date
1	RSF Road - Camino De Los Coches to Avenida Aragon	Traffic Control	CCTV'd in FY18	3	FY21
2	RSF Road - Calle Acevo to Avenida Aragon	Traffic Control	CCTV'd in FY21	3	FY24
3	La Costa Ave - Piraeus St to Saxony PS	Traffic Control	CCTV'd in FY21	3	FY24
4	ECR - Enci Blvd to Leucadia Blvd	Night Work	CCTV'd in FY18	3	FY21
5	ECR - Leucadia Blvd to Levante (Green Valley)	Easement hydro-cleaning	CCTV'd in FY18	3	FY21
6	ECR - Levante to 300' north of La Costa Ave	Traffic Control	CCTV'd in FY18	3	FY21
7A	La Costa Golf Course (North Portion)	Coordination w/ golf course	CCTV'd in FY19	3	FY22
7B	La Costa Golf Course (East Portion)	Coordination w/ golf course	CCTV'd in FY19	3	FY22
9	Alga Road and El Camino Real	Traffic Control	CCTV'd in FY21	3	FY24
10	La Costa Ave	Traffic Control	CCTV'd in FY21	3	FY24
11	RSF Road - Paseo Lupino to La Costa Avenue	Traffic Control	CCTV'd in FY18	3	FY21
