## **LEUCADIA WASTEWATER DISTRICT SEWER SYSTEM MANAGEMENT PLAN FISCAL YEAR 2022 AUDIT**

October 31, 2022

**Prepared by:  
Dexter Wilson Engineering, Inc.  
2234 Faraday Avenue  
Carlsbad, CA 92008**

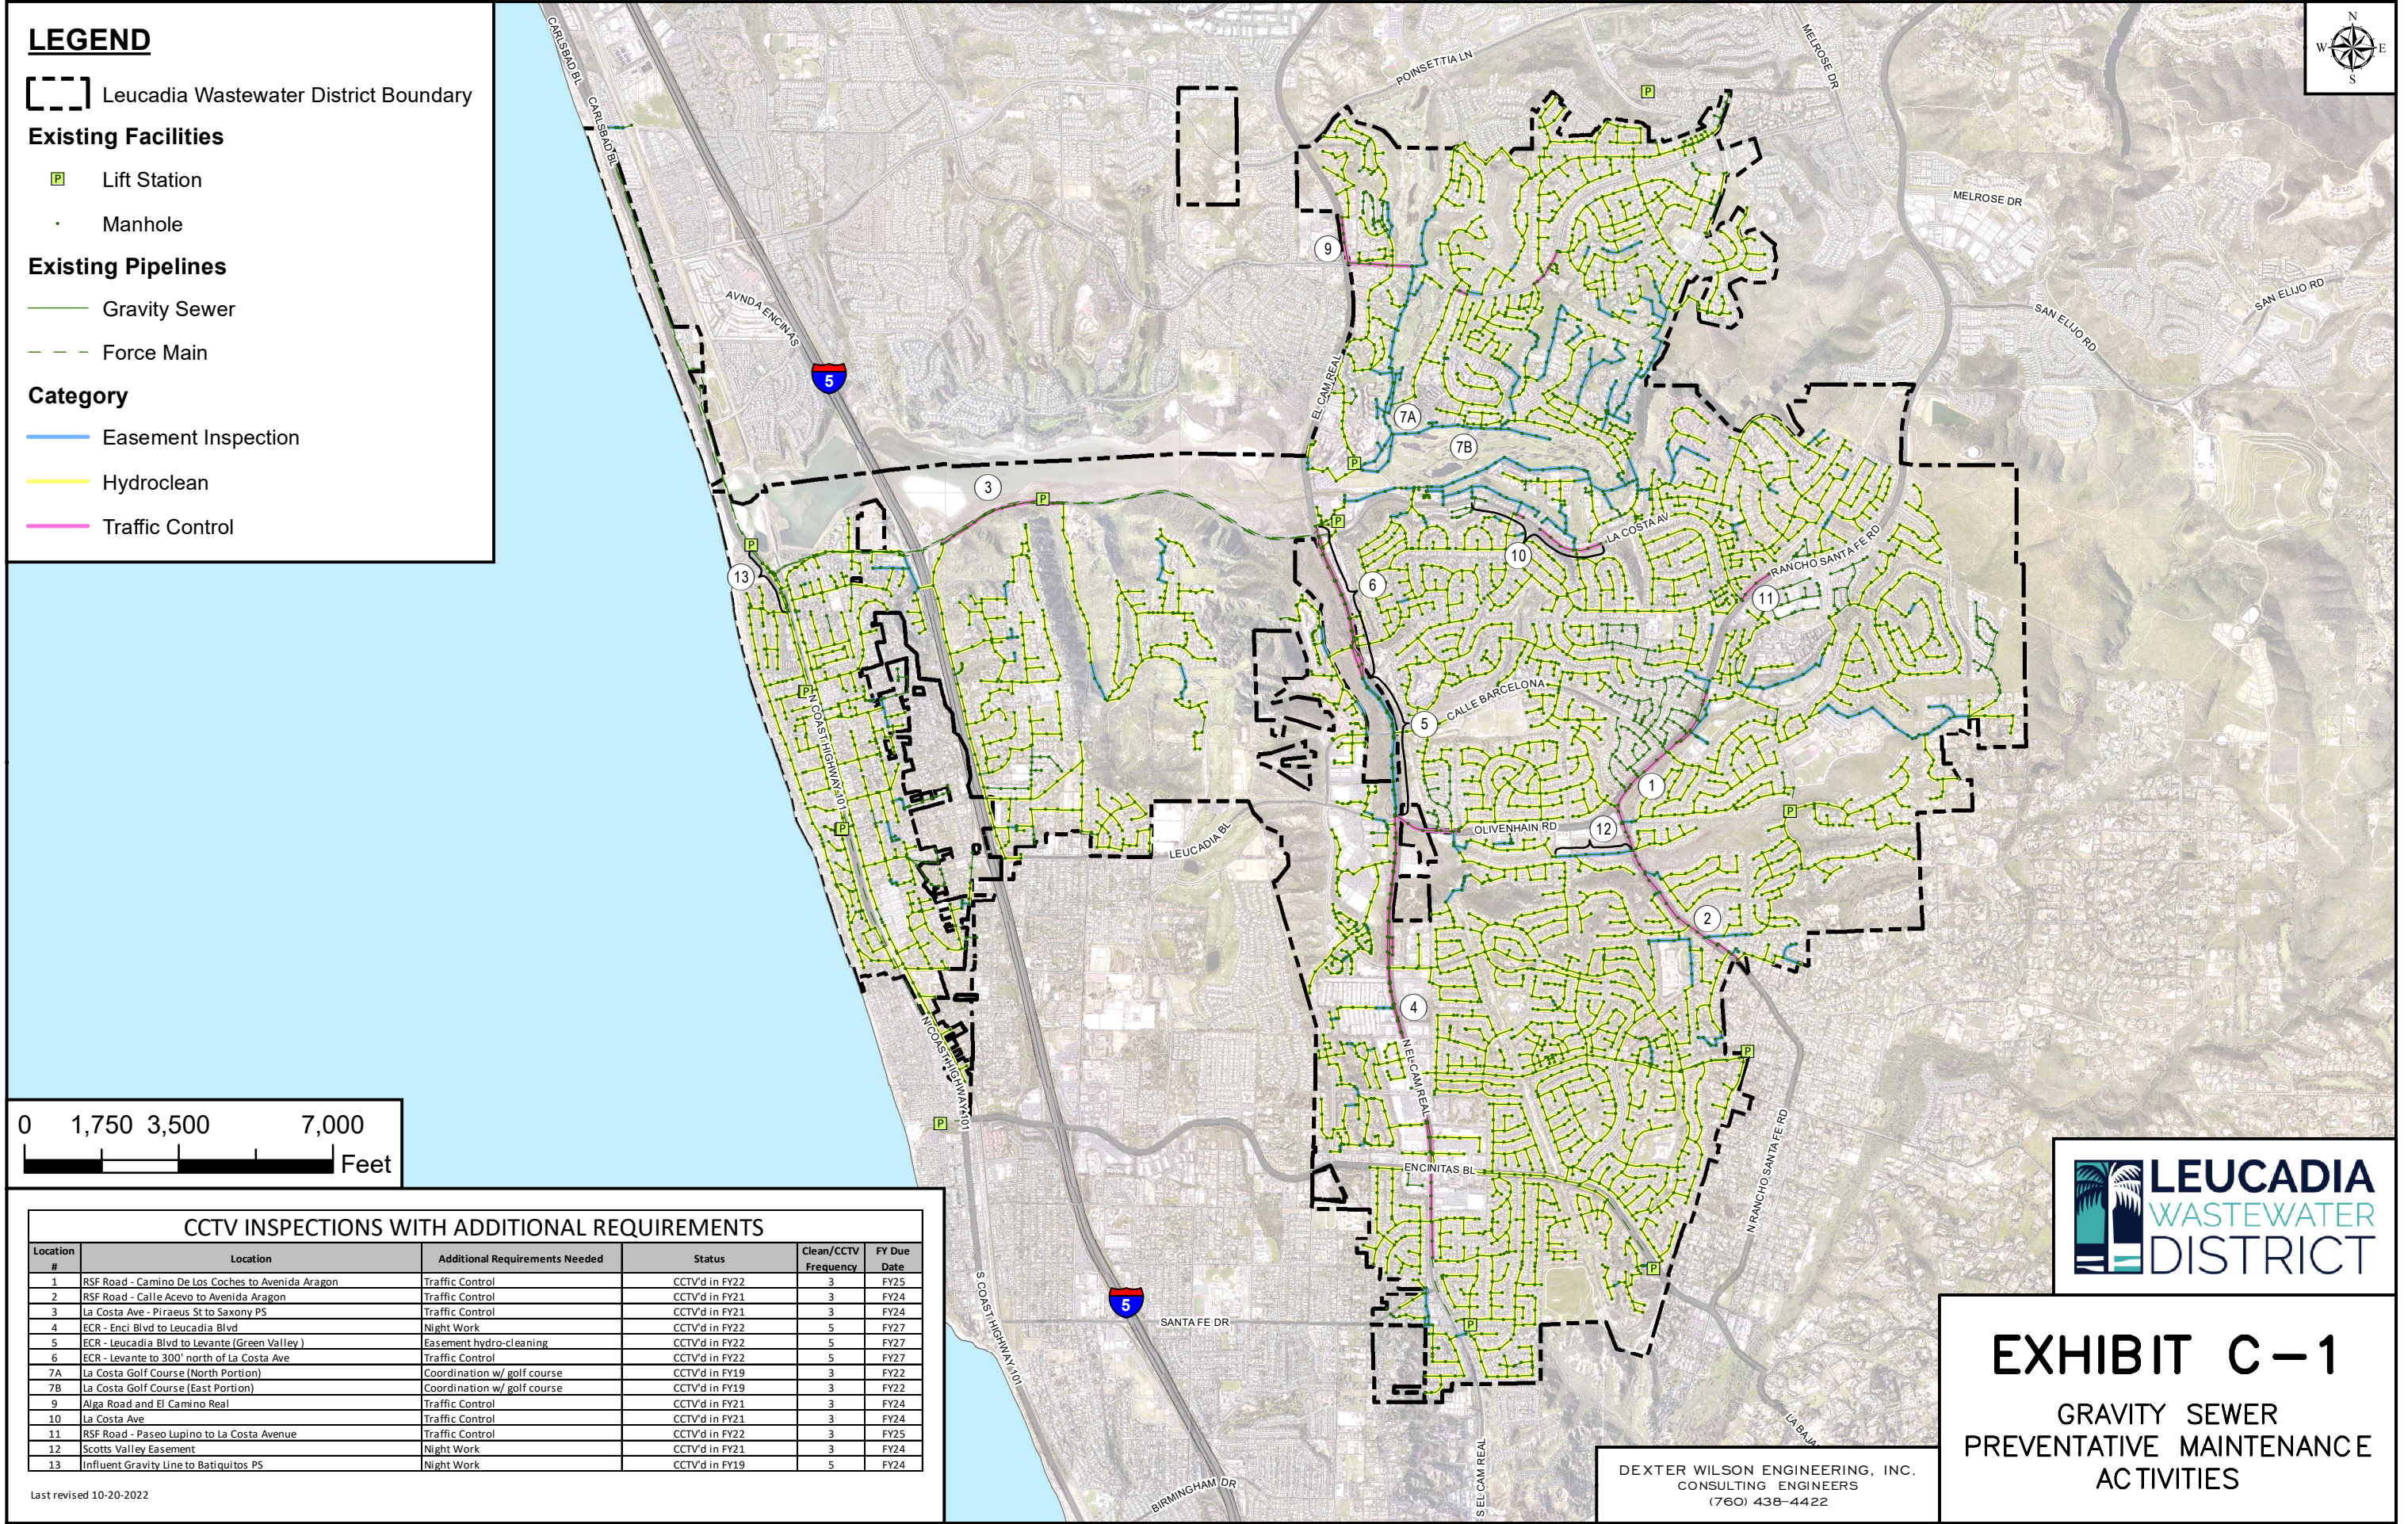
### CCTV INSPECTIONS WITH ADDITIONAL REQUIREMENTS

Location #	Location	Additional Requirements Needed	Status	Clean/CCTV Frequency	FY Due Date
1	RSF Road - Camino De Los Coches to Avenida Aragon	Traffic Control	CCTV'd in FY22	3	FY25
2	RSF Road - Calle Acevo to Avenida Aragon	Traffic Control	CCTV'd in FY21	3	FY24
3	La Costa Ave - Piraeus St to Saxony PS	Traffic Control	CCTV'd in FY21	3	FY24
4	ECR - Enci Blvd to Leucadia Blvd	Night Work	CCTV'd in FY22	5	FY27
5	ECR - Leucadia Blvd to Levante (Green Valley)	Easement hydro-cleaning	CCTV'd in FY22	5	FY27
6	ECR - Levante to 300' north of La Costa Ave	Traffic Control	CCTV'd in FY22	5	FY27
7A	La Costa Golf Course (North Portion)	Coordination w/ golf course	CCTV'd in FY19	3	FY22
7B	La Costa Golf Course (East Portion)	Coordination w/ golf course	CCTV'd in FY19	3	FY22
9	Alga Road and El Camino Real	Traffic Control	CCTV'd in FY21	3	FY24
10	La Costa Ave	Traffic Control	CCTV'd in FY21	3	FY24
11	RSF Road - Paseo Lupino to La Costa Avenue	Traffic Control	CCTV'd in FY22	3	FY25
