LEUCADIA WASTEWATER DISTRICT

HAZARD PREPAREDNESS & MITIGATION PLAN

Plan Update
February 2021

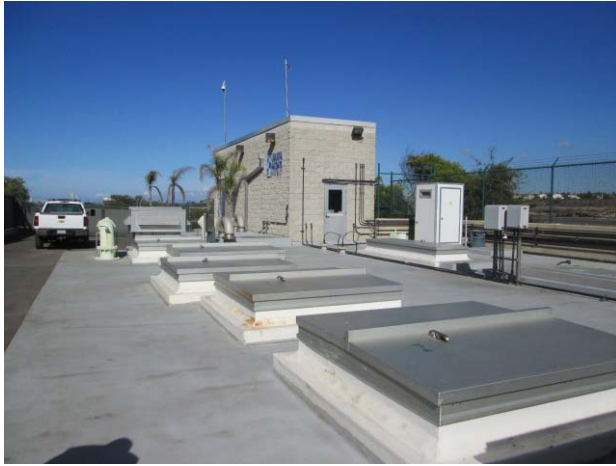
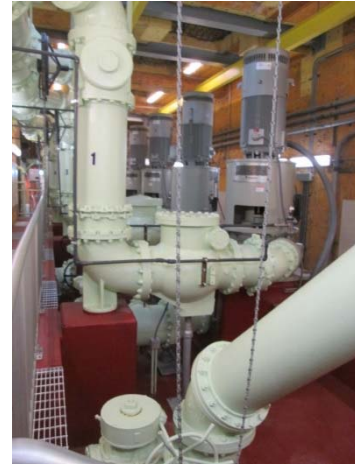
The Batiquitos Pump Station contains four pumps (lead, lag, and two standby), which can pump 8,000 gallons per minute with one force main and two pumps and 12,000 gallons per minute with two force mains and two pumps. Each of the pumps is equipped with a 250 horsepower motor controlled with a variable speed drive. During dry weather flows, the lead and lag pumps pump into one of the two pump station force mains. During extreme wet weather flows, the lead and lag pumps can pump into both force mains. Bypass piping and valving is available at this pump station to bypass the pump station and utilize the pump station force mains. If required, the District has a portable pump capable of bypassing the pump station into either force main.

The Batiquitos Pump Station has a cast-in-place concrete wet well, dry well, emergency overflow basin, and dual force mains. A 480V emergency diesel generator is located on site that autostarts on a loss of power and is sized to provide enough power to two pumps. Additionally, an odor control system (Vapex fog system and US Filter Midas Carbon scrubber) is located onsite to eliminate pump station odors. The pump station conveys flows from both the District and the City of Encinitas. The District owns 77.86 percent of the pump station and the City of Encinitas owns 22.14 percent.

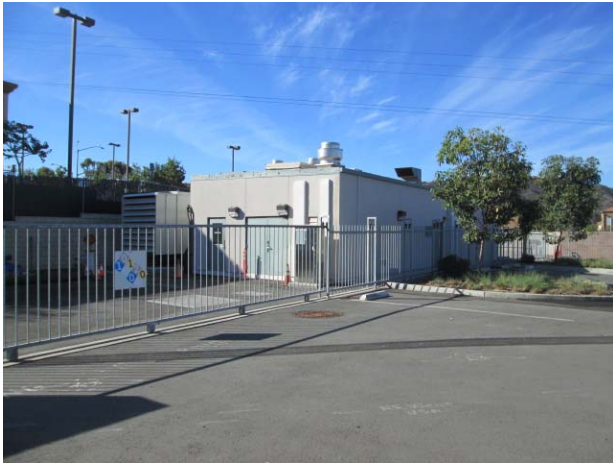
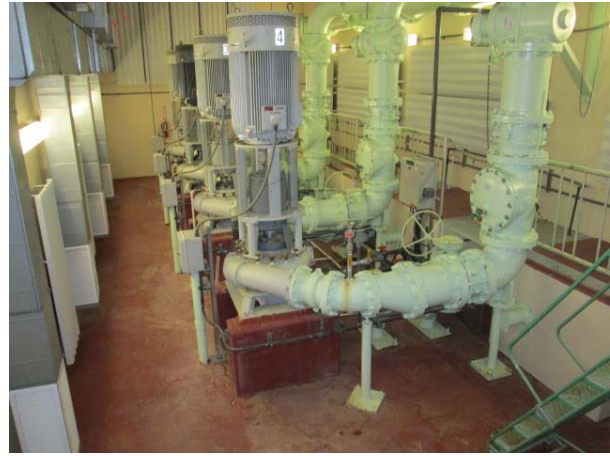
The Leucadia Pump Station has a cast-in-place concrete wet well, dry well, and an above grade building. The pump station is located at the District headquarters and collects the majority of the flow from the eastern end of the Batiquitos Lagoon and pumps it west along La Costa Avenue. The pump station contains four 200 horsepower pumps (lead, lag, and two standby). The station is capable of pumping 6,500 gallons per minute with one force main and two pumps and 9,000 gallons per minute with 2 force mains and two pumps. The pump station is also configured with an emergency overflow basin, which allows for bypass pumping, and dual force mains (L1 and L2) to provide redundancy. If required, the District has a portable pump capable of bypassing the pump station into either force main.

A 480V emergency diesel generator is located on site that autostarts on a loss of power and is sized to provide sufficient power to the pump station, main office and buildings 200, 300 & 400. Additionally, an odor control system (Vapex fog system and US Filter Midas Carbon scrubber) is located onsite to eliminate pump station odors. Bioxide is also injected at the pump station to reduce H₂S formation in the force main.

The Leucadia Pump Station Rehabilitation Project is under construction. Following project implementation, the station will be configured with dry pit submersible pumps with the following specifications: Three 150 HP pumps (duty point: 4,000 gpm @ 95 feet TDH) and two 25 HP pumps (duty point: 873 gpm @ 70 feet TDH). The Emergency Overflow Basin contains a submersible pump that discharges directly into either force main. The project includes adding an ECO₂ super-oxygenation odor control system for odor and force main corrosion control. Additionally, all piping, valves, check valves and the discharge header in the dry well will be replaced, as well as the flow meter.

The soils report for the Administration Building, which is collocated with the Leucadia Pump Station, states that the potential for liquefaction in the area is low. This is due to the high clay content in the alluvium deposit and the dense nature of the shallow underlying formational soils above the water table.

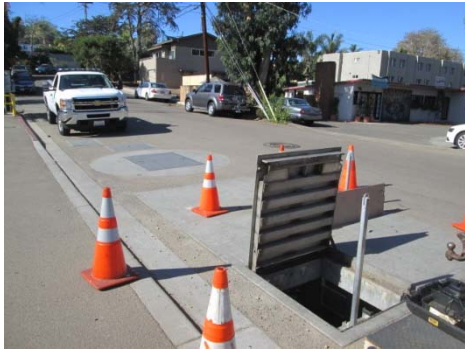
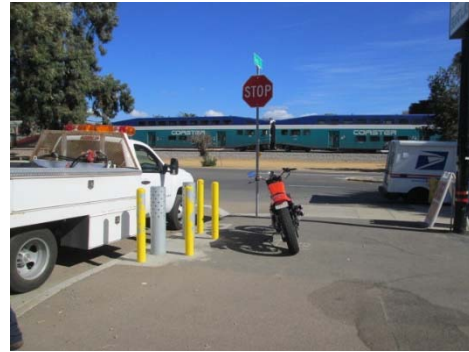
The Diana Pump Station is a submersible pump station with above ground controls with a PVC force main. Approximately 250 feet of the force main is paralleled (PVC) in a 30" steel casing under Highway 101 and the railroad tracks from the pump station to Vulcan Avenue. The pump station contains two 15 horsepower pumps, duty and standby, each of which can pump 750 gallons per minute. Bypass piping and valving is available at this pump station to bypass the pump station and utilize the pump station force mains. The pump station is equipped with a power receptacle and a manual transfer switch. In the case of a power failure, a trailer mounted portable standby diesel generator (480V/240V) is available as the source of emergency electrical power.

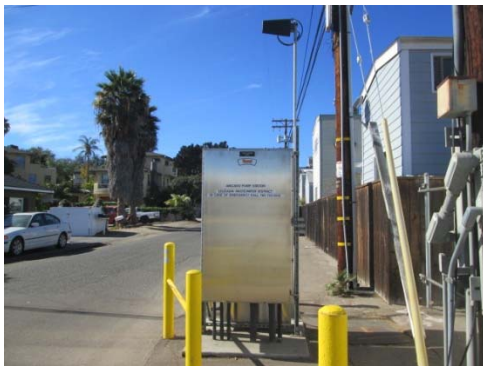
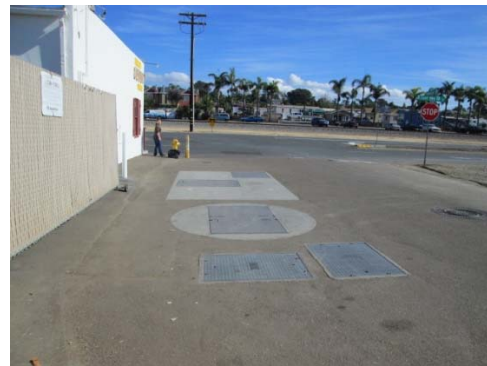
The Avocado Pump Station is a submersible pump station with above ground controls and a PVC parallel force main installed under Highway 101 and the railroad tracks. The pump station has two three horsepower pumps, duty and standby, each of which is capable of pumping 300 gallons per minute. Bypass piping and valving is available at this pump station to bypass the pump station and utilize the pump station force mains. The pump station is equipped with a power receptacle and a manual transfer switch. In the case of a power failure, a trailer mounted portable standby diesel generator (480V/240V) is available as the source of emergency electrical power.

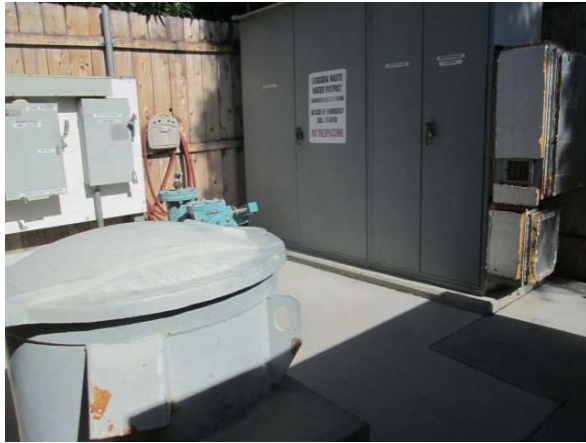
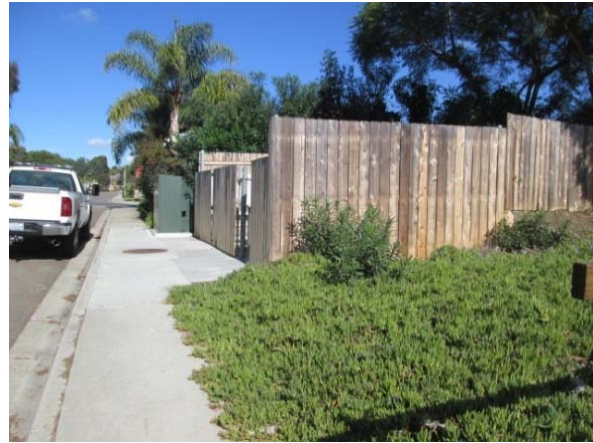
The Encinitas Estates Pump Station contains two 40 horsepower pumps, duty and standby, each of which pumps 450 gallons per minute and a 6-inch PVC force main. Bypass piping and valving is available at this pump station to bypass the pump station and utilize the pump station force main. The Encinitas Estates Pump Station is configured with an emergency generator that utilizes natural gas from SDG&E and autostarts on a loss of power or below normal power (loss of phase, voltage drop, etc.).

The packaged pump station is being replaced with a submersible pump station. The pump station will have two 17 horsepower pumps, duty and standby, each of which pumps 186 gallons per minute. The emergency natural gas powered generator and associated electrical equipment will be replaced.

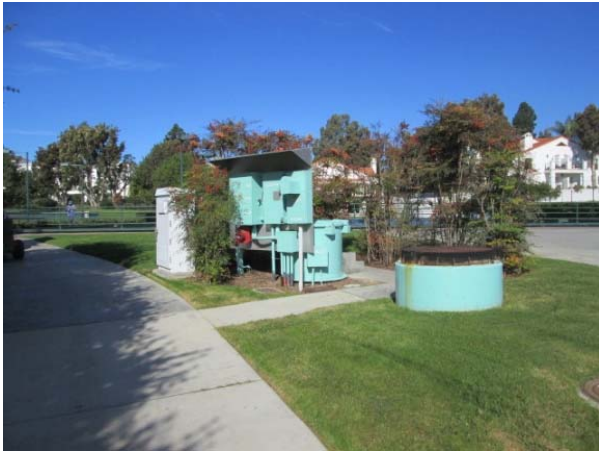
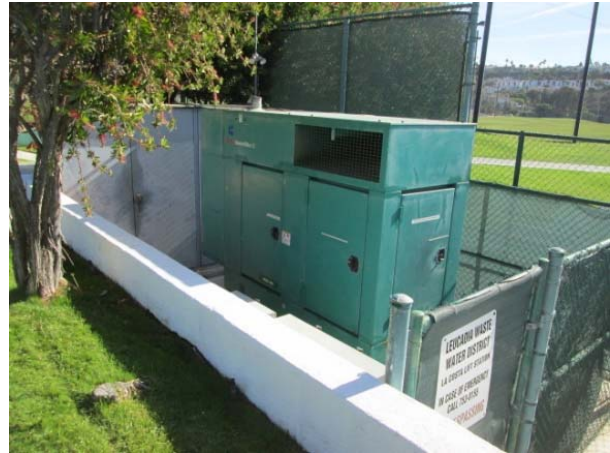
The La Costa Pump Station contains two 30 horsepower pumps, duty and standby, each of which can pump 2,200 gallons per minute. The La Costa Pump Station has a single force main with a short section of 10-inch PVC force main installed in 1976 and a 12-inch PVC force main installed in 1998. The force main transitions to a 12-inch HDPE force main which was directionally drilled under San Marcos Creek in 1998. Bypass piping and valving is available at this pump station to bypass the pump station and utilize the pump station force mains. The La Costa Pump Station is also configured with an onsite emergency generator (integral diesel fuel) that autostarts on a loss of SDG&E electrical power or below normal (loss of phase, voltage drop, etc.).

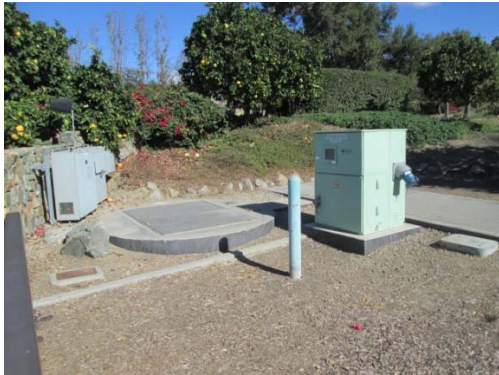
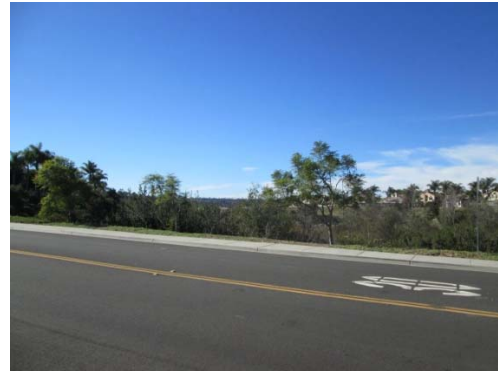
The Rancho Verde Pump Station has a concrete wet well with submersible pumps and above ground structure. The pump station has two 7.5 horsepower pumps, duty and standby, each of which has a pumping capacity of 250 gallons per minute. The pump station is equipped with a power receptacle and a manual transfer switch. In the case of a power failure, a trailer mounted portable standby diesel generator (480V/240V) is available as the source of emergency electrical power.

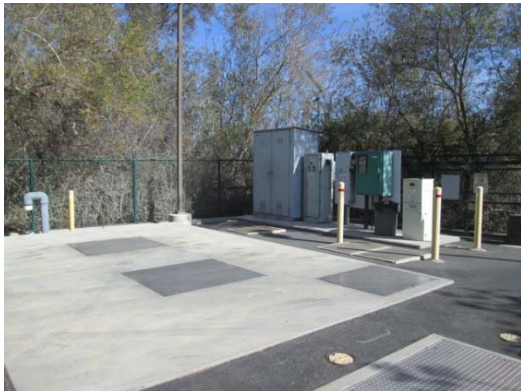
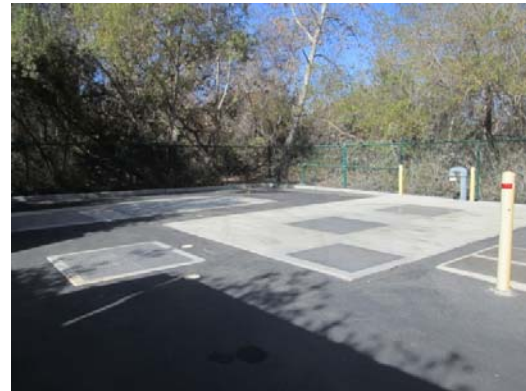
The Saxony Pump Station has a concrete wet well with submersible pumps and an above ground structure. The pump station has two 40 horsepower pumps, duty and standby, each of which has a pumping capacity of 900 gallons per minute. In 2001, the offsite portion of the force main was replaced to connect to both Leucadia Pump Station force mains, L1 and L2. Bypass piping and valving is available at this pump station to bypass the pump station and utilize the pump station force main. The Saxony Pump Station is also configured with an onsite emergency generator (integral diesel fuel) that autostarts on a loss of SDG&E electrical power or below normal (loss of phase, voltage drop, etc.). The Saxony Pump Station is also configured with the ability to inject Bioxide, which is currently not in use.

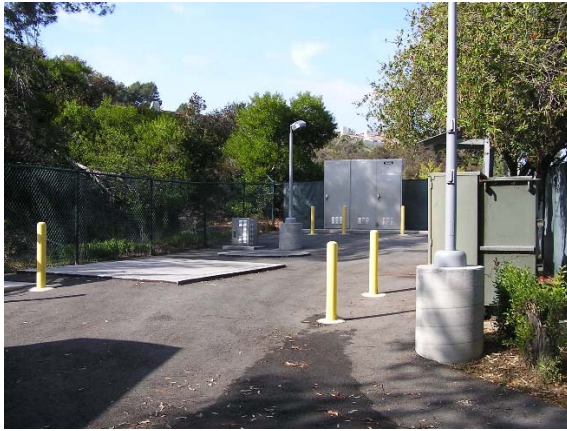
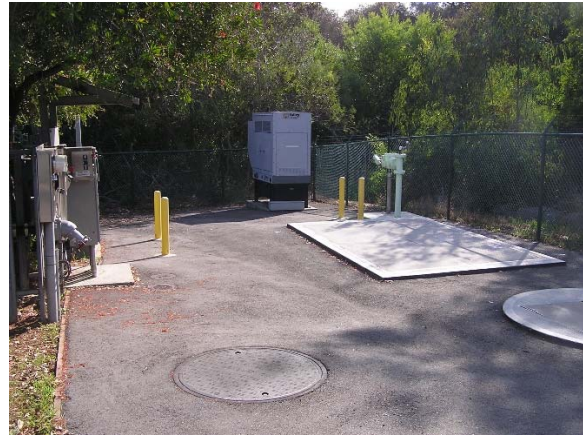
The Village Park 5 Pump Station contains two 15 horsepower pumps, duty and standby, each of which has a pumping capacity of 215 gallons per minute and a 6-inch PVC force main. Bypass piping and valving is available at this pump station to bypass the pump station and utilize the pump station force main. The Village Park 5 Pump Station is also configured with an onsite emergency generator (integral diesel fuel) that autostarts on a loss of SDG&E electrical power or below normal.

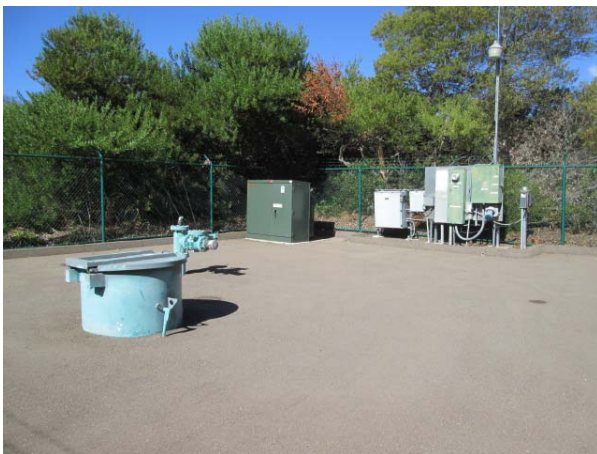
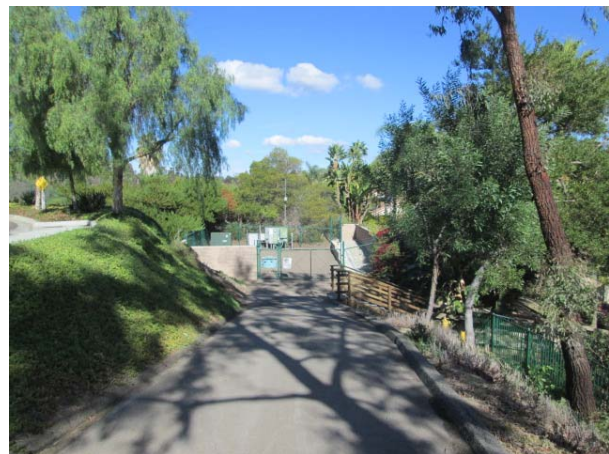
The Village Park 7 Pump Station contains two 20 horsepower pumps, duty and standby, each of which has a pumping capacity of 200 gallons per minute and a 6-inch PVC force main. Bypass piping and valving is available at this pump station to bypass the pump station and utilize the pump station force main. The pump station is equipped with a power receptacle and a manual transfer switch. In the case of a power failure, a trailer mounted portable standby diesel generator (480V/240V) is available as the source of emergency electrical power.

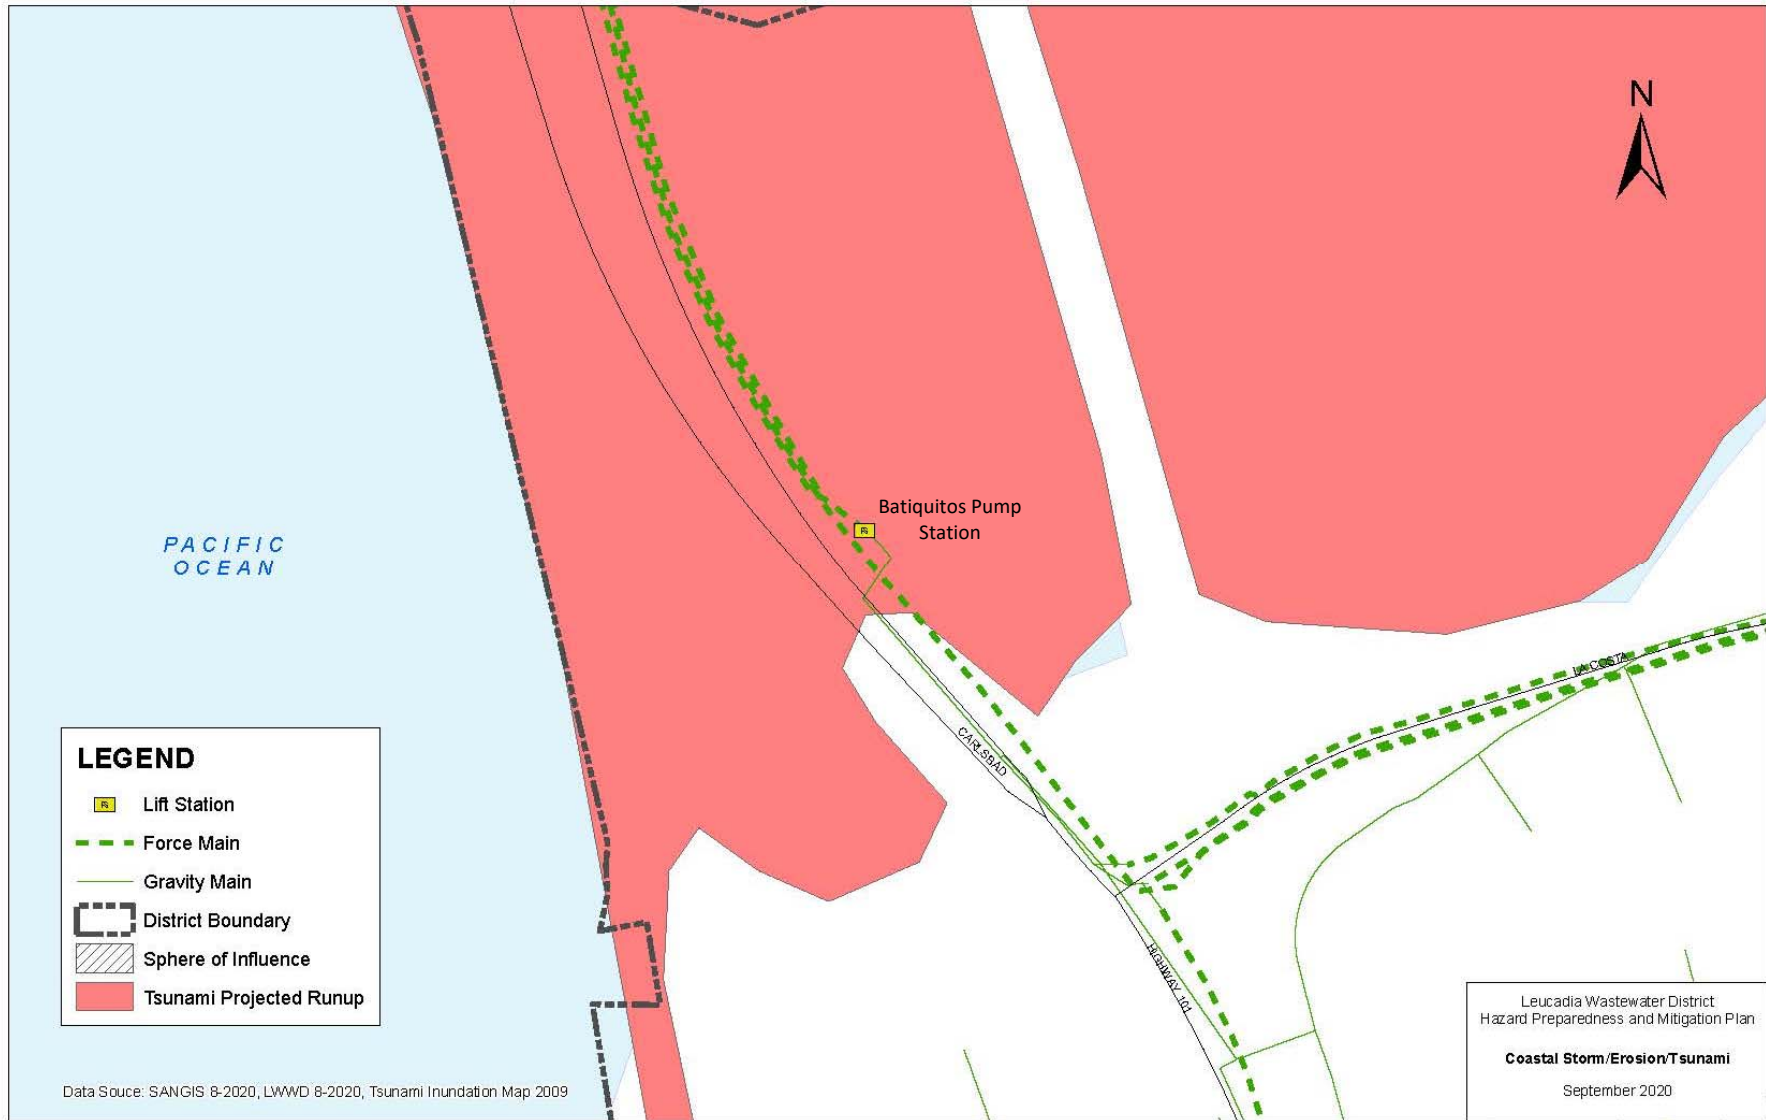
According to the tsunami inundation maps, the Batiquitos Pump Station is the only District facility located within the inundation zone. Inundation would be severe and result in potential failure of the pump station electrical equipment (including pump motors) and controls.

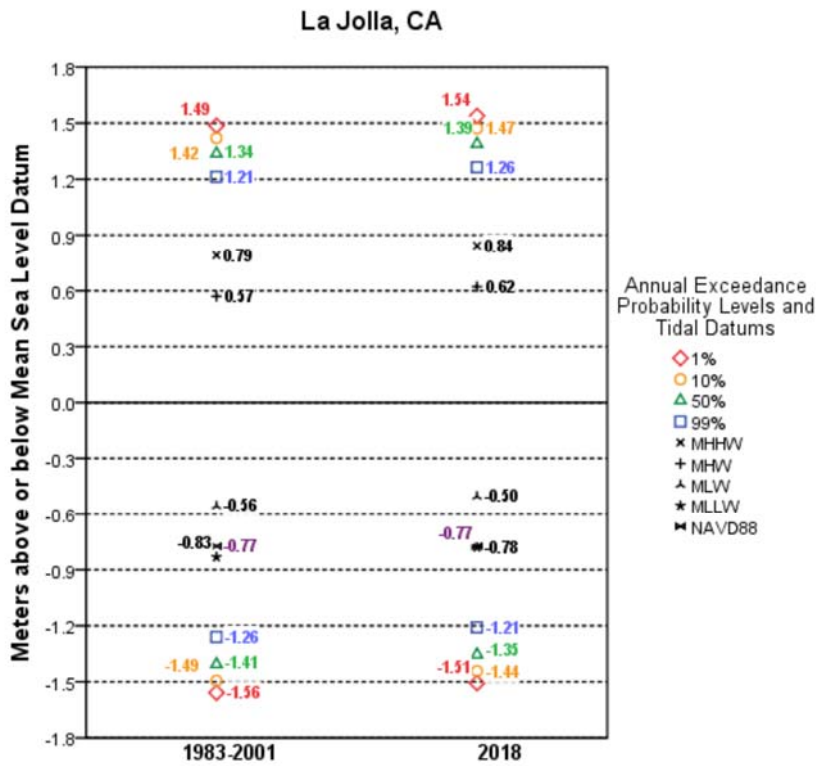
High and low annual exceedance probability levels are shown below relative to the tidal datums and the geodetic NAVD88. The levels are in meters relative to the National Tidal Datum Epoch (1983-2001) Mean Sea Level datum of 2.54 feet. The extreme levels measured by the NOAA Center for Operational Oceanographic Products and Services (CO-OPS) tide gauges during storms are called storm tides, which are a combination of the astronomical tide, the storm surge, and limited wave setup caused by breaking waves. They do not include wave runup, the movement of water up a slope and are thus, different than the FEMA 100-year flood zone.

The figure above from NOAA indicates that there is a 1% chance of a tide 1.54 meters (5.0 feet), 10% chance of a tide 1.47 meters (4.8 feet), 50% chance of a tide 1.39 meters (4.5 feet), and 99% chance of a tide 1.26 meters (4.1 feet) above the mean sea level datum of 2.73 feet at the La Jolla station in 2018. This is representative of potential tide fluctuations that could impact the Batiquitos, Saxony, La Costa and Leucadia Pump Stations that are located along the floodplain.

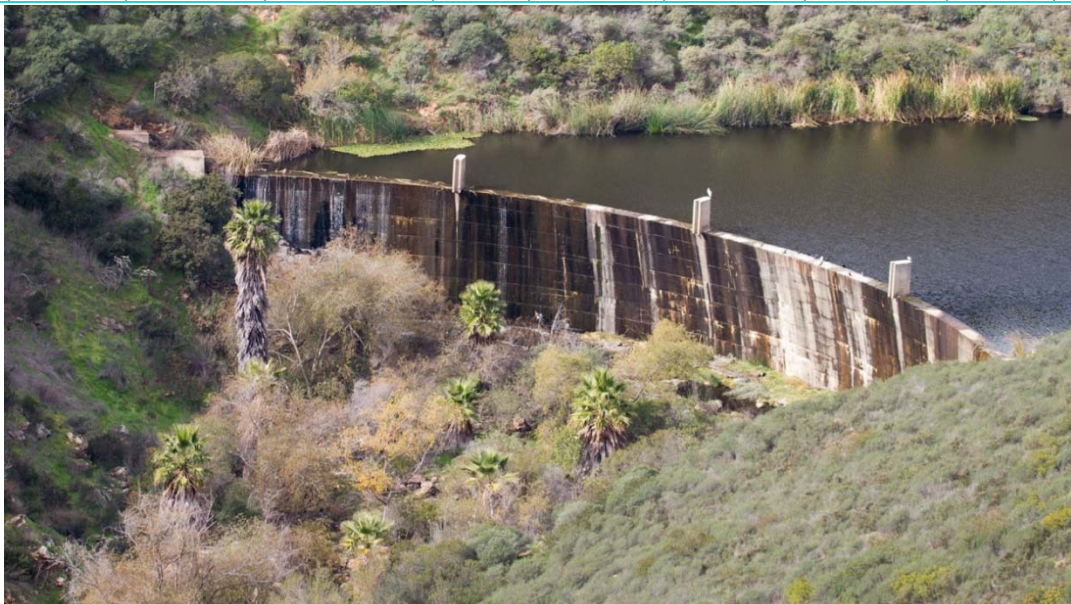
The La Costa Pump Station and Leucadia Pump Station are both located in the vicinity of the inundation zone from the San Marcos Lake Dam; however, they are both outside the inundation zone. The following table provides dam details:

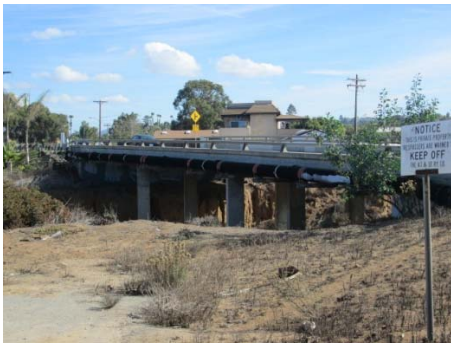
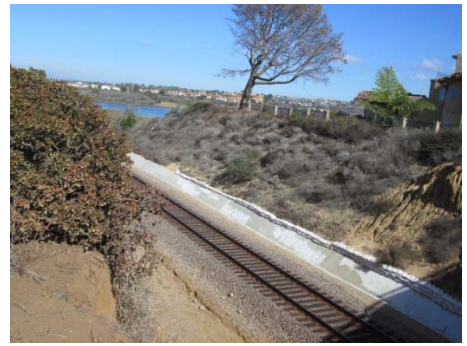
Railroad Crossing

Highways and railroad bridges often support pipelines. Movements of a bridge structure with respect to its abutments may damage the pipeline. Collapse of the bridge will destroy the pipeline segment. If the bridge collapses, repair of the pipeline requires extensive and expensive temporary pipe bridge or other means, pending repair or replacement of the bridge. Meaningful assessment of the bridge’s vulnerability, and its potential relative movements (structure versus abutments) requires a high level of effort and significant expertise (with specific bridge engineering details). Good engineering practices for pipelines on bridge crossings includes flexible restrained joints and lateral supports and appropriate redundancy for anchors / supports. Note, that the District replaced the section of the Leucadia (L1) Force Main west of Interstate 5 and moved the alignment to the south side of La Costa Avenue and installed flexible couplings on both sides of the bridge to mitigate seismic concerns. However, even with good engineering practices considering seismic hazards, the locations where the District force mains cross the railroad, cross Interstate 5, and along the Pacific Coast Highway bridge are vulnerable to failure during seismic events.
