**LEUCADIA WASTEWATER DISTRICT  
ASSET MANAGEMENT PLAN  
2018 UPDATE**

May 25, 2018

**Prepared by:  
Dexter Wilson Engineering, Inc.  
2234 Faraday Avenue  
Carlsbad, CA 92008  
(760) 438-4422**

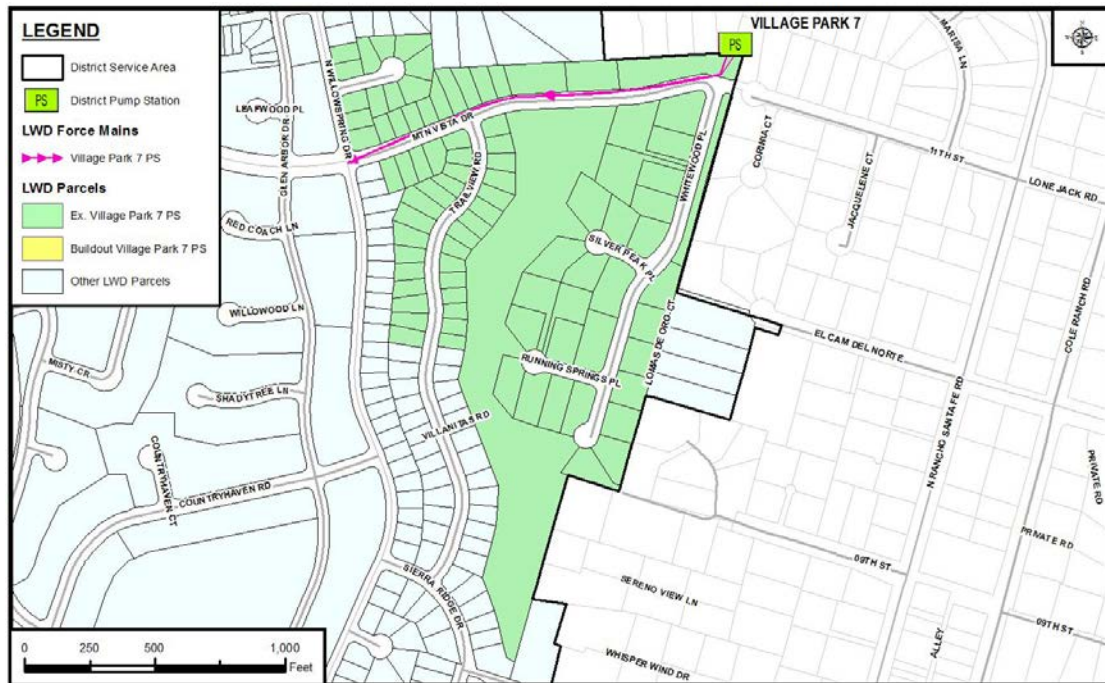
**FIGURE 2-11. VILLAGE PARK 7 PUMP STATION BASIN**

The Village Park #7 Pump Station is a Smith and Loveless package station built in 1973. The pump station contains two pumps, duty and standby, each of which has a capacity of 200 gallons per minute. Each of the pumps is driven by a 20-horsepower motor. The original AC force main was replaced in 2010 with 6-inch PVC. Bypass piping and valving is available at this pump station to bypass the pump station and utilize the pump station force main. Village Park #7 Pump Station is located near the District's eastern boundary along Mountain Vista Drive.

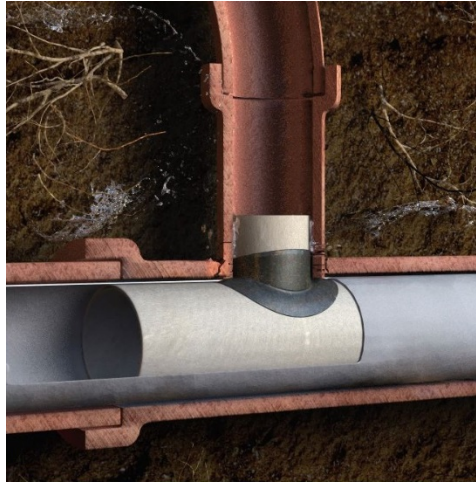
**FIGURE 5-3. LATERAL LINING “TOP HATS”**

- As a result of the SMA evaluation completed in the 2013 AMP, a trial lining project (part of the FY13 Gravity Rehabilitation Project) was recommended to evaluate the viability of lining pipelines versus replacement as a long-term solution to chronic root problems and to evaluate technologies available to address laterals with roots. More specifically, the trial portion of the project (located in Drainage Basin #3 along Hygeia Avenue and Sanford Street) was to not only CIPP line 1,636 feet of pipeline, but to install "full circumference top hats" (a method to eliminate roots at lateral joints and depicted in Figure 5-3) in the 37 laterals within the lining area. The 2013 AMP contemplated testing T-liners as well, however only top hats were pursued. Field staff's recent review of CCTV tapes for this area show no issues at the lateral connection and thus the top hat seems to be successful.

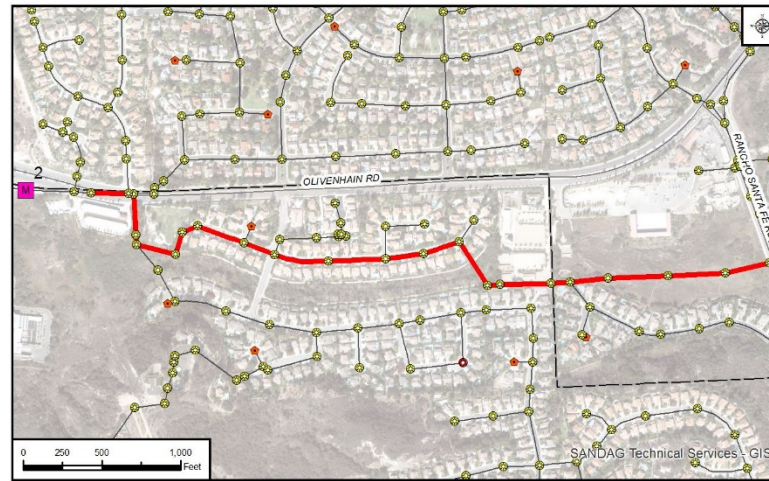
**FIGURE 5-4. SCOTT'S VALLEY PIPELINE ALIGNMENT**

- In FY16, a CIP project was completed to line approximately 678 feet of VCP pipeline known as the Scott’s Valley Pipeline (Drainage Basin #8), as seen in Figure 5-4. The project also installed three cured in place manhole liners in manholes along the Scott’s Valley Pipeline and epoxy lined six manholes in the Circulo-Ardorno area. This area was known to contribute inflow and infiltration. In review of dry weather and wet weather flow data, summarized in Table 5-1, lining this length of pipeline did help decrease infiltration into the District’s system. The average and peak dry weather flow measured at submeter 2 just downstream of Scott’s Valley decreased by approximately 6 percent after the segment was lined. During wet weather flow, however, inflow still occurs in this area and has actually slightly increased. It should

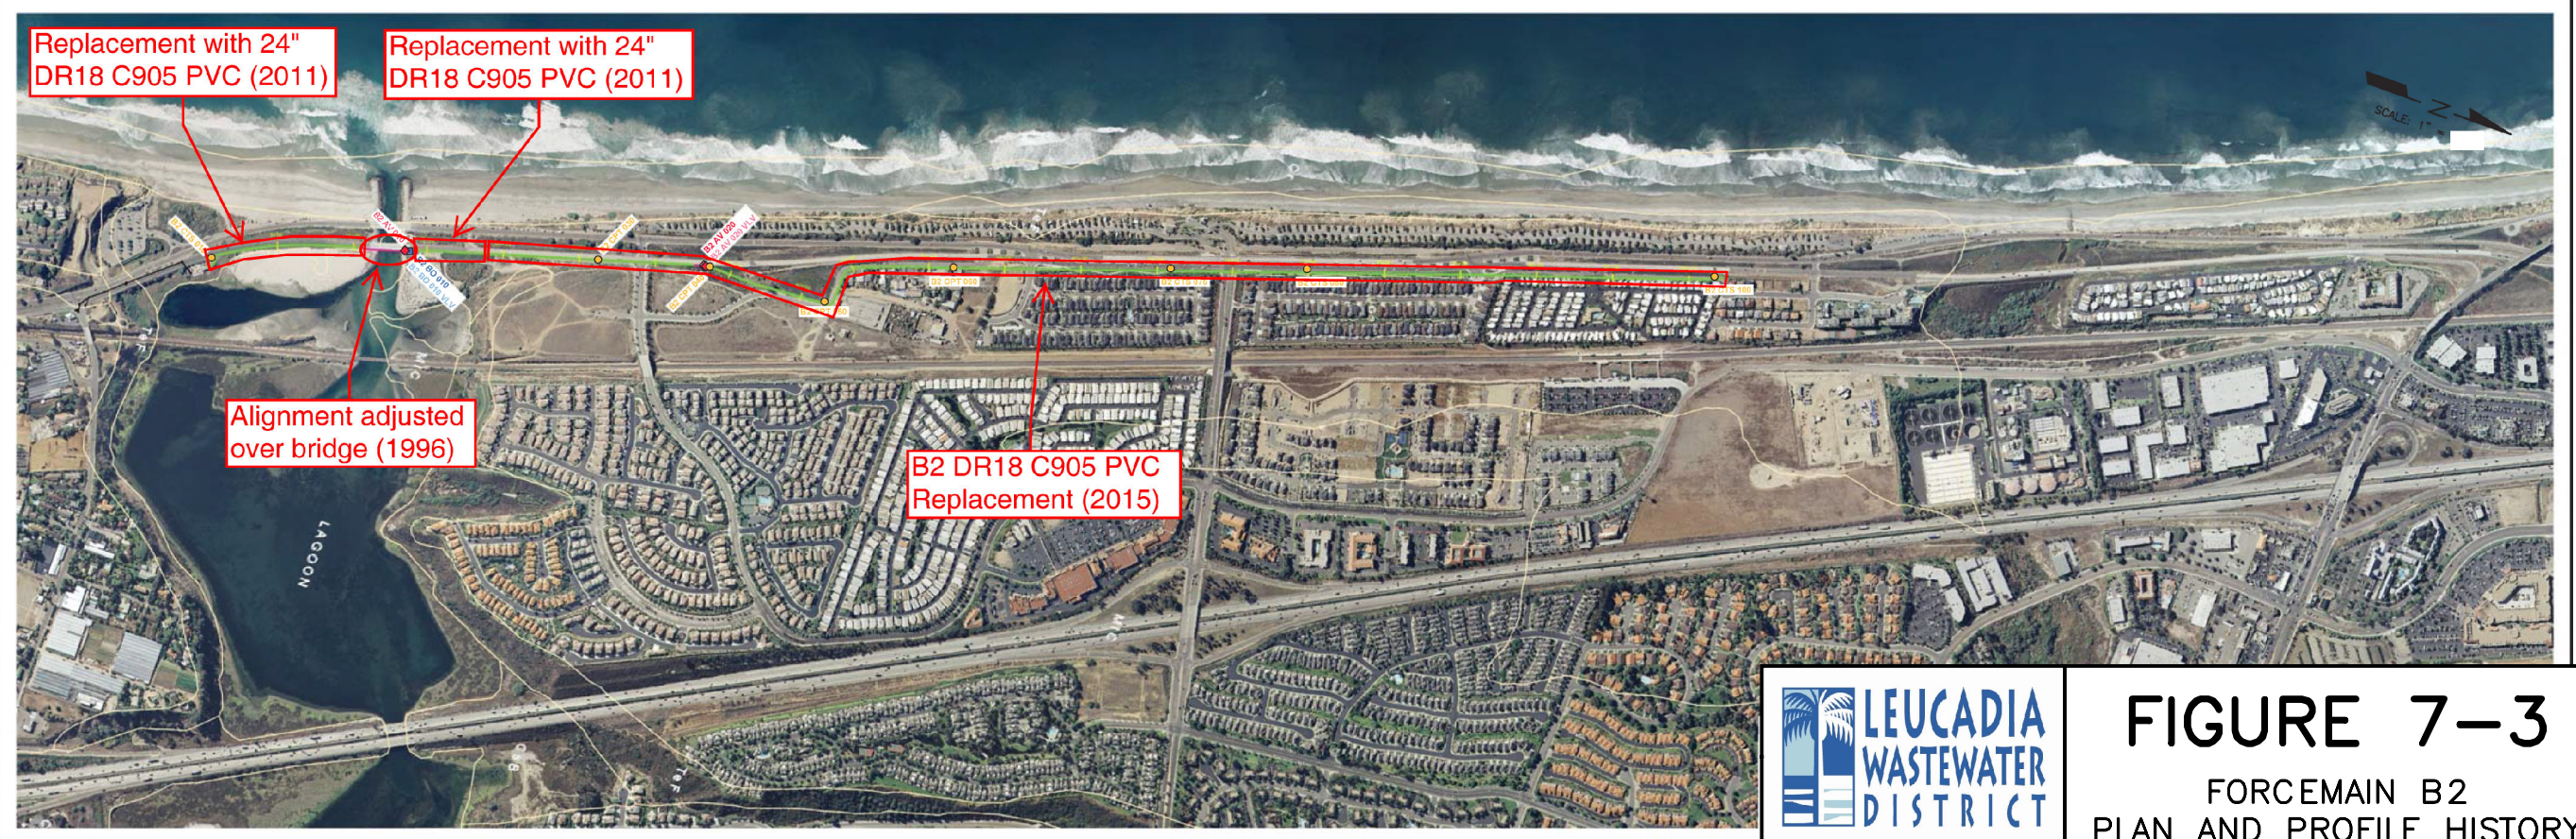
Detailed plan and profile information current as of 2009. Figure is for overview/CIP planning only.

B2 initially constructed in 1979

Replacement with 24" DR18 C905 PVC (2011)

B2 DR18 C905 PVC Replacement (2015)

The installation history of the B2 force main is summarized in the table below. The oldest section is the 25-year-old above-ground, polylined, ductile iron bridge crossing, with the remaining PVC pipeline less than 10 years old. A project has been added to the 20 Year CIP to line the ductile iron section when the segment reaches 30 years of age in 2026.

<b>TABLE 7-4 B2 FORCE MAIN HISTORY</b>				
<b>Year</b>	<b>Event</b>	<b>Station Begin</b>	<b>Station End</b>	<b>Length, feet</b>
1979	B2 Phase 2 installed – ductile iron	0+22.62	102+63.29	10,240.67
1996	Adjust B2 alignment over Batiquitos Lagoon bridge – ductile iron (lined)	10+80	14+60	380
2011	Partial replacement from the Batiquitos Pump Station to the San Marcos Creek Bridge. Force Main was replaced with 24-inch DR18 C905 PVC.	-	-	1,100
2011	Partial replacement from the San Marcos Creek Bridge to the north. Force Main was replaced with 24-inch DR18 C905 PVC.	-	-	400
2015	B2 replacement – DR18 C905 PVC (same trench as B1)	-	-	8,463
