DEXTER WILSON ENGINEERING, INC.

LEUCADIA WASTEWATER DISTRICT SEWER SYSTEM MANAGEMENT PLAN FISCAL YEAR 2017 AUDIT

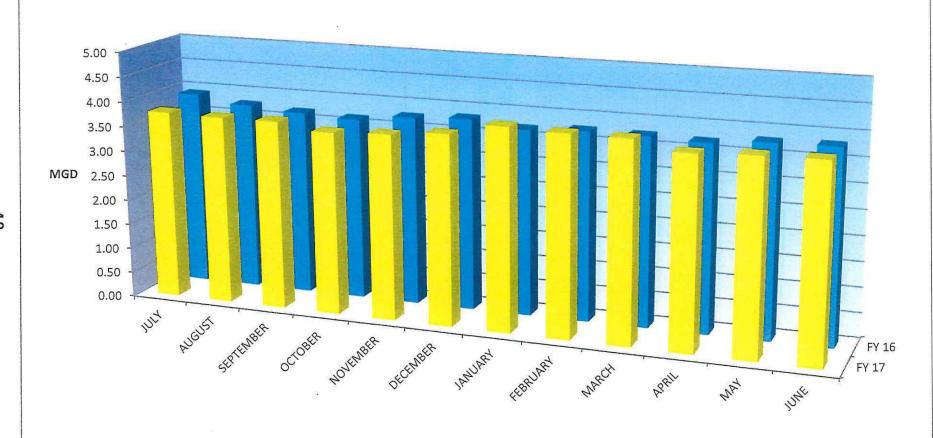
Leucadia Wastewater District Flow Comparison FY 16 to FY 17

The District's monthly flow comparison between FY16 and FY17 can be found in Attachment F.
