LEUCADIA WASTEWATER DISTRICT

HAZARD PREPAREDNESS & MITIGATION PLAN

Final Report
April 2015

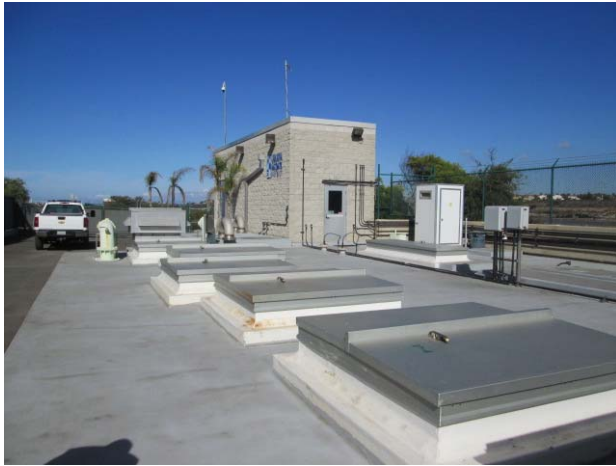
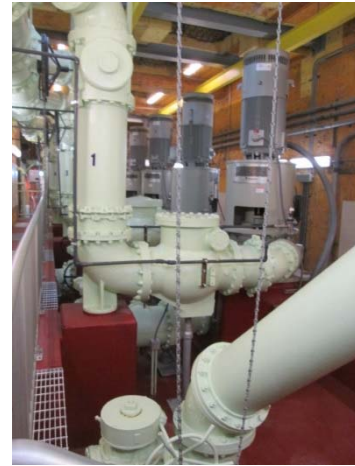
The Batiquitos Pump Station contains four pumps (lead, lag, and two standby), which can pump 8,000 gallons per minute with one force main and two pumps and 12,000 gallons per minute with two force mains and two pumps. Each of the pumps is equipped with a 250 horsepower motor controlled with a variable speed drive. During dry weather flows, the lead and lag pumps pump into one of the two pump station force mains. During extreme wet weather flows, the lead and lag pumps can pump into both force mains. Bypass piping and valving is available at this pump station to bypass the pump station and utilize the pump station force mains. If required, the portable pump Big Blue, is capable of pumping 6,000 gpm with one force main and 7,200 gpm with two force mains.

The Batiquitos Pump Station has a cast-in-place concrete wet well, dry well, emergency overflow basin, and dual force mains. A 480V emergency diesel generator is located on site that autostarts on a loss of power and is sized to provide enough power to two pumps. Additionally, an odor control system (Vapex fog system and US Filter Midas Carbon scrubber) is located onsite to eliminate pump station odors. The pump station conveys flows from both the District and the City of Encinitas. The District owns 77.86 percent of the pump station and the City of Encinitas owns 22.14 percent.

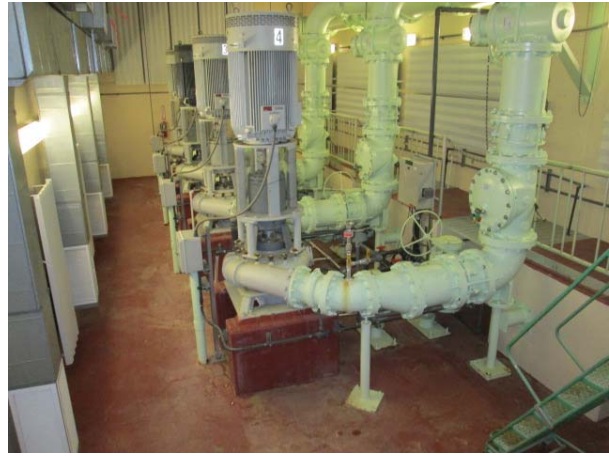
The Leucadia Pump Station has a cast-in-place concrete wet well, dry well, and an above grade building. The pump station is located at the District headquarters and collects the majority of the flow from the eastern end of the Batiquitos Lagoon and pumps it west along La Costa Avenue. The pump station contains four 200 horsepower pumps (lead, lag, and two standby). The station is capable of pumping 6,500 gallons per minute with one force main and two pumps and 9,000 gallons per minute with 2 force mains and two pumps. The pump station is also configured with an emergency overflow basin, which allows for bypass pumping, and dual force mains (L1 and L2) to provide redundancy. If required, the portable pump Big Blue, is capable of pumping 6,000 gpm with one force main and 7,200 gpm with two force mains.

A 480V emergency diesel generator is located on site that autostarts on a loss of power and is sized to provide sufficient power to the pump station, main office and buildings 200,300 & 400. Additionally, an odor control system (Vapex fog system and US Filter Midas Carbon scrubber) is located onsite to eliminate pump station odors. Bioxide is also injected at the pump station to reduce H₂S formation in the force main.

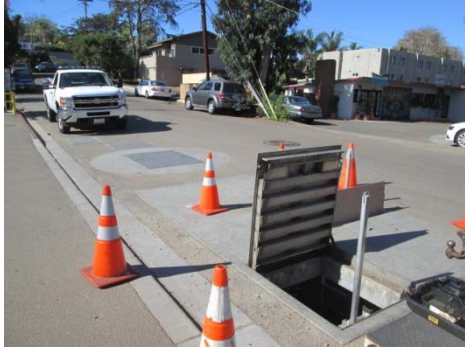
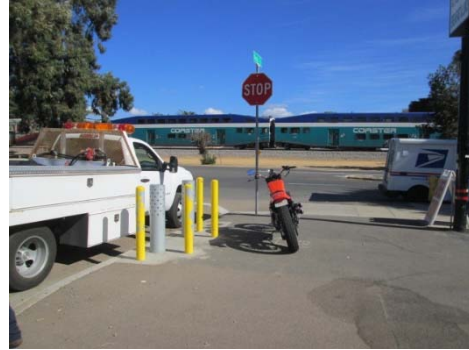
The Diana Pump Station is a submersible pump station with above ground controls with a PVC force main. Approximately 250 feet of the force main is paralleled (PVC) in a 30" steel casing under Highway 101 and the railroad tracks from the pump station to Vulcan Avenue. The pump station contains two 15 horsepower pumps, duty and standby, each of which can pump 750 gallons per minute. Bypass piping and valving is available at this pump station to bypass the pump station and utilize the pump station force mains. The pump station is equipped with a power receptacle and a manual transfer switch. In the case of a power failure, a trailer mounted portable standby diesel generator (480V/240V) is available as the source of emergency electrical power.

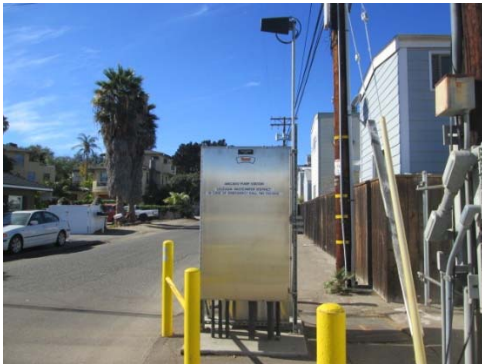
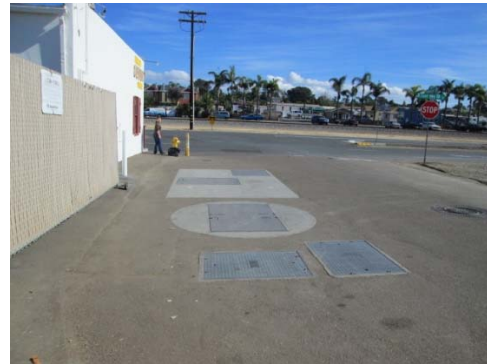
The Avocado Pump Station is a submersible pump station with above ground controls and a PVC parallel force main installed under Highway 101 and the railroad tracks. The pump station has two three horsepower pumps, duty and standby, each of which is capable of pumping 300 gallons per minute. Bypass piping and valving is available at this pump station to bypass the pump station and utilize the pump station force mains. The pump station is equipped with a power receptacle and a manual transfer switch. In the case of a power failure, a trailer mounted portable standby diesel generator (480V/240V) is available as the source of emergency electrical power.

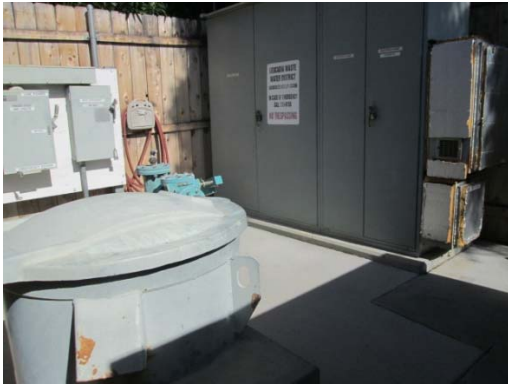
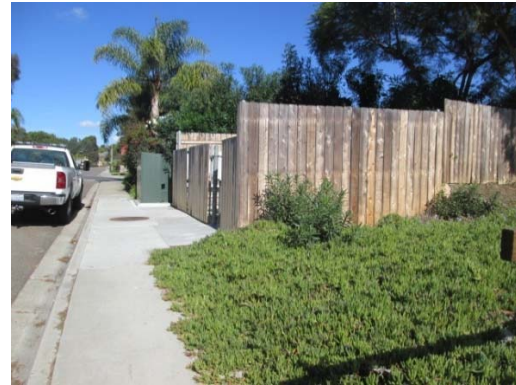
The Encinitas Estates Pump Station contains two 40 horsepower pumps, duty and standby, each of which pumps 450 gallons per minute and a 6-inch PVC force main. Bypass piping and valving is available at this pump station to bypass the pump station and utilize the pump station force main. The Encinitas Estates Pump Station is configured with an emergency generator that utilizes natural gas from SDG&E and autostarts on a loss of power or below normal power (loss of phase, voltage drop, etc.).

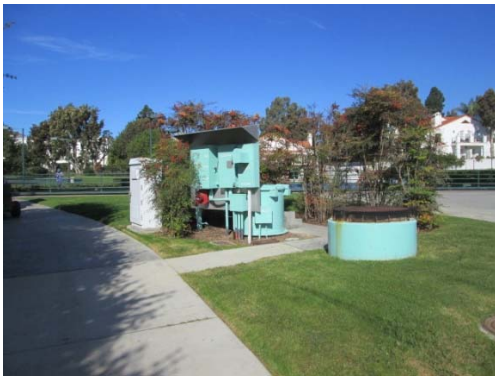
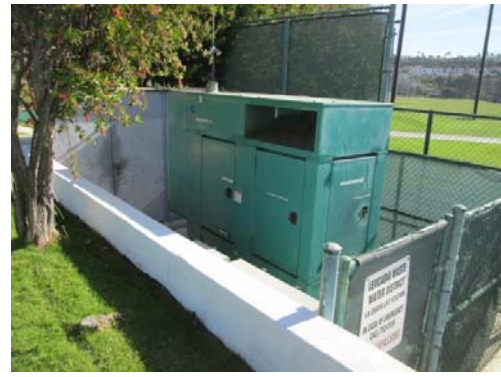
The La Costa Pump Station contains two 30 horsepower pumps, duty and standby, each of which can pump 2,200 gallons per minute. The La Costa Pump Station has parallel force mains: a 10-inch PVC force main installed in 1976 and a 12-inch PVC force main installed in 1998. The force mains are interconnected such that either can be directed to the 12-inch HDPE force main which was directionally drilled under San Marcos Creek in 1998 and both discharge to the same downstream manhole. Bypass piping and valving is available at this pump station to bypass the pump station and utilize the pump station force mains. The La Costa Pump Station is also configured with an onsite emergency generator (integral diesel fuel) that autostarts on a loss of SDG&E electrical power or below normal (loss of phase, voltage drop, etc.).

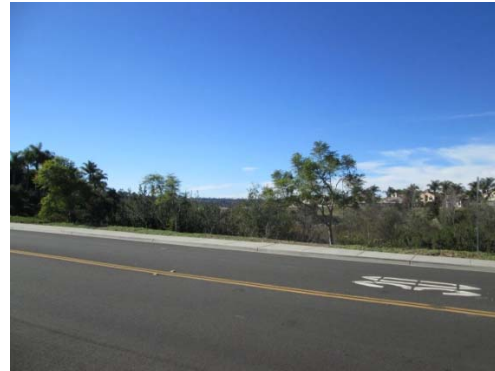
The Rancho Verde Pump Station has a concrete wet well with submersible pumps and above ground structure. The pump station has two 7.5 horsepower pumps, duty and standby, each of which has a capacity of 250 gallons per minute. The pump station is equipped with a power receptacle and a manual transfer switch. In the case of a power failure, a trailer mounted portable standby diesel generator (480V/240V) is available as the source of emergency electrical power.

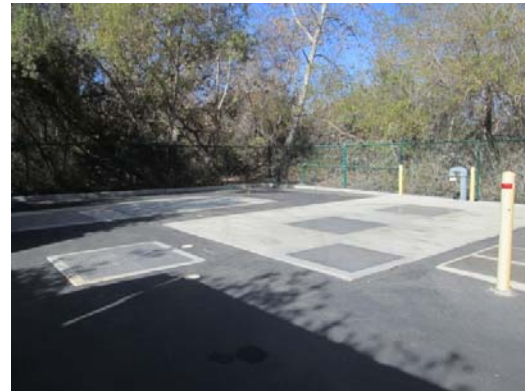
The Saxony Pump Station has a concrete wet well with submersible pumps and an above ground structure. The pump station has two 40 horsepower pumps, duty and standby, each of which has a capacity of 900 gallons per minute. In 2001, the offsite portion of the force main was replaced to connect to both Leucadia Pump Station force mains, L1 and L2. Bypass piping and valving is available at this pump station to bypass the pump station and utilize the pump station force main. The Saxony Pump Station is also configured with an onsite emergency generator (integral diesel fuel) that autostarts on a loss of SDG&E electrical power or below normal (loss of phase, voltage drop, etc.). The Saxony Pump Station is also configured with the ability to inject Bioxide, which is not in use.

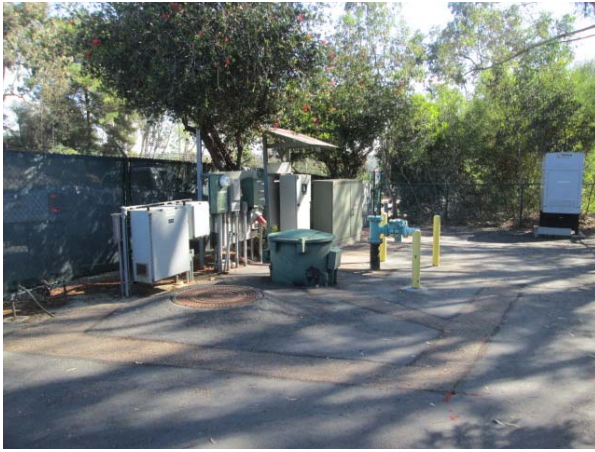
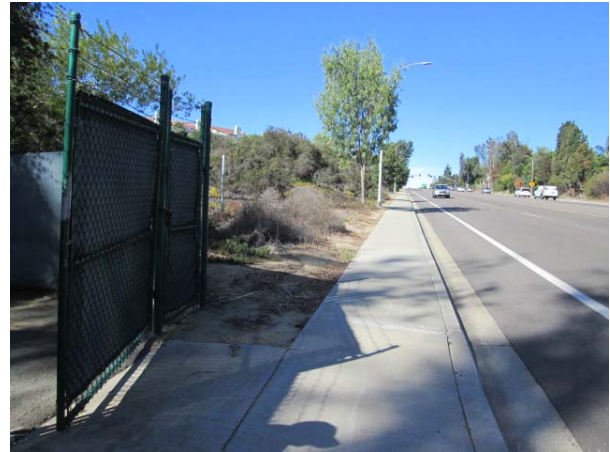
The Village Park 5 Pump Station contains two 15 horsepower pumps, duty and standby, each of which has a capacity of 250 gallons per minute and a 6-inch PVC force main. Bypass piping and valving is available at this pump station to bypass the pump station and utilize the pump station force main. The Village Park 5 Pump Station is also configured with an onsite emergency generator (integral diesel fuel) that autostarts on a loss of SDG&E electrical power or below normal (loss of phase, voltage drop, etc.).

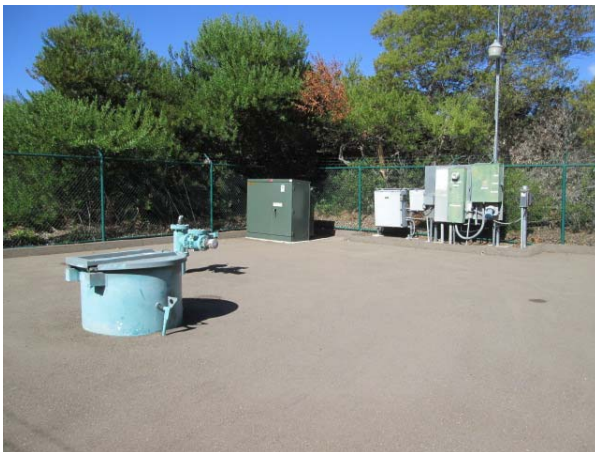
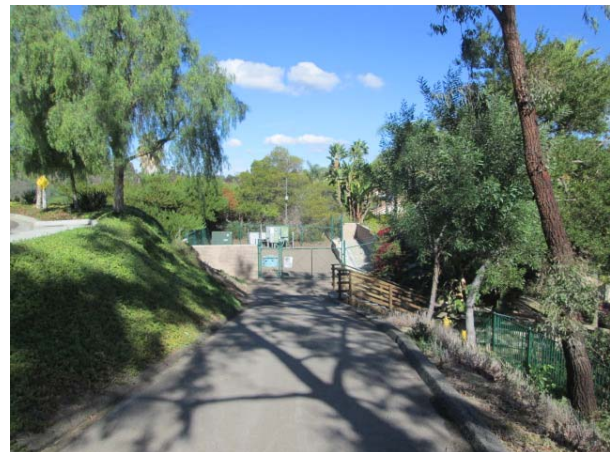
Village Park 7 Pump Station

The Village Park 7 Pump contains two 20 horsepower pumps, duty and standby, each of which has a capacity of 200 gallons per minute and a 6-inch PVC force main. Bypass piping and valving is available at this pump station to bypass the pump station and utilize the pump station force main. The pump station is equipped with a power receptacle and a manual transfer switch. In the case of a power failure, a trailer mounted portable standby diesel generator (480V/240V) is available as the source of emergency electrical power.

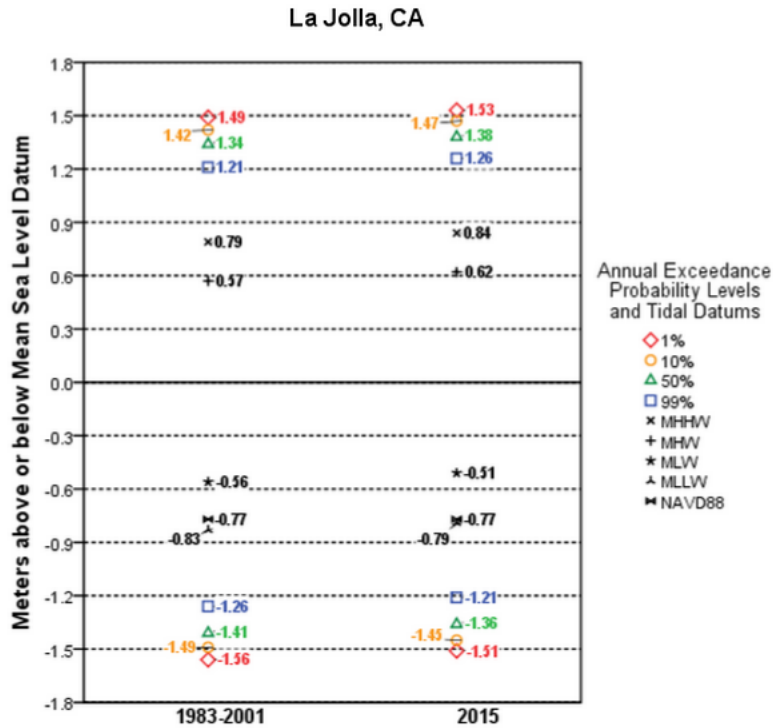
The figure above from NOAA indicates that there is a 1% chance of a tide 1.53 meters (5.0 feet), 10% chance of a tide 1.47 meters (4.8 feet), 50% chance of a tide 1.38 meters (4.5 feet), and 99% chance of a tide 1.26 meters (4.1 feet) above the mean sea level datum of 2.73 feet at the La Jolla station in 2015. This is representative of potential tide fluctuations that could impact the Batiquitos, Saxony, La Costa and Leucadia Pump Stations that are located along the floodplain.

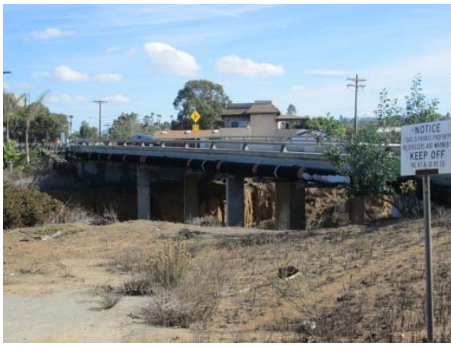
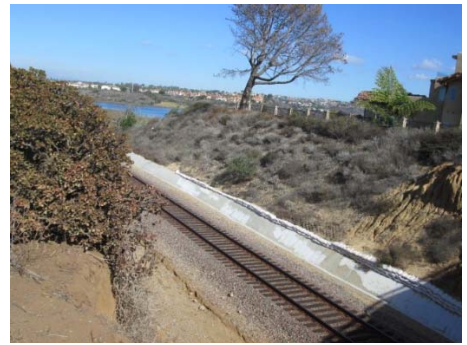
Railroad Crossing

Highways and railroad bridges often support pipelines. Movements of a bridge structure with respect to its abutments may damage the pipeline. Collapse of the bridge will destroy the pipeline segment. If the bridge collapses, repair of the pipeline requires extensive and expensive temporary pipe bridge or other means, pending repair or replacement of the bridge. Meaningful assessment of the bridge's vulnerability, and its potential relative movements (structure versus abutments) requires a high level of effort and significant expertise (with specific bridge engineering details). Good engineering practices for pipelines on bridge crossings includes flexible restrained joints and lateral supports and appropriate redundancy for anchors / supports. Even with good engineering practices considering seismic hazards, the locations where the Leucadia Wastewater District force mains cross the railroad, cross Interstate 5, and along the Pacific Coast Highway are vulnerable to failure during seismic events.

5. Review detailed engineering analysis for the force mains at the railroad crossing and Pacific Coast Highway Bridge to ensure the design considered seismic hazards and follows good engineering practices (e.g., flexible restrained joints, lateral supports, anchorage redundancy, etc.).	Force Mains	Earthquake

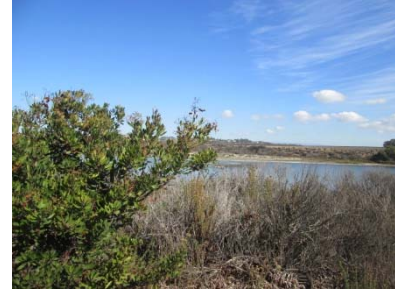
Inundation of the Batiquitos Pump Station can result in damage to the pump electrical equipment/controls and diesel generator in the dry well as well as electrical equipment and controls in the above-grade control room. Additionally, failure of the pump station would have significant secondary impacts including the total loss of sewer services for the District service area (approximately 60,000 customers) and the overflow of sewage directly into the Batiquitos Lagoon with environmental impacts, public health impacts, and associated fines and clean-up costs.

If the damage is electrical (loss of power or flooded dry well) with the structure of the pump station still intact, the diesel driven bypass pump (Big Blue) can be connected in approximately 3 to 4 hours. However, this would require a diver to go into the dry well to open the suction valve or pump out the dry well just enough to enable a person to go in and open the valve. Thus, it can be up to 6 to 8 hours after the debris/water is cleared and access to the pump station is established to get the equipment in place. If the pump station structure; wet well, emergency basin, etc. is damaged, the pump station would have to be bypassed from La Costa Avenue to north of the Lanikai Lane Mobile Home Park (manhole to manhole) which is approximately 10,500 feet. Based on the amount of damage to the force main, intermediate manholes could be constructed on the north and south undamaged force mains sections for bypassing. Thereby, reducing the bypass pumping distance. This would have to be hard pipe with bypass pump(s), which may take up to two weeks. Loss estimates in the table are listed on a per day basis.
